# Arboricultural Assessment

## 35 - 39 Regent Street, Mount Waverley

Prepared for: Japara HealthCare

7 July 2016

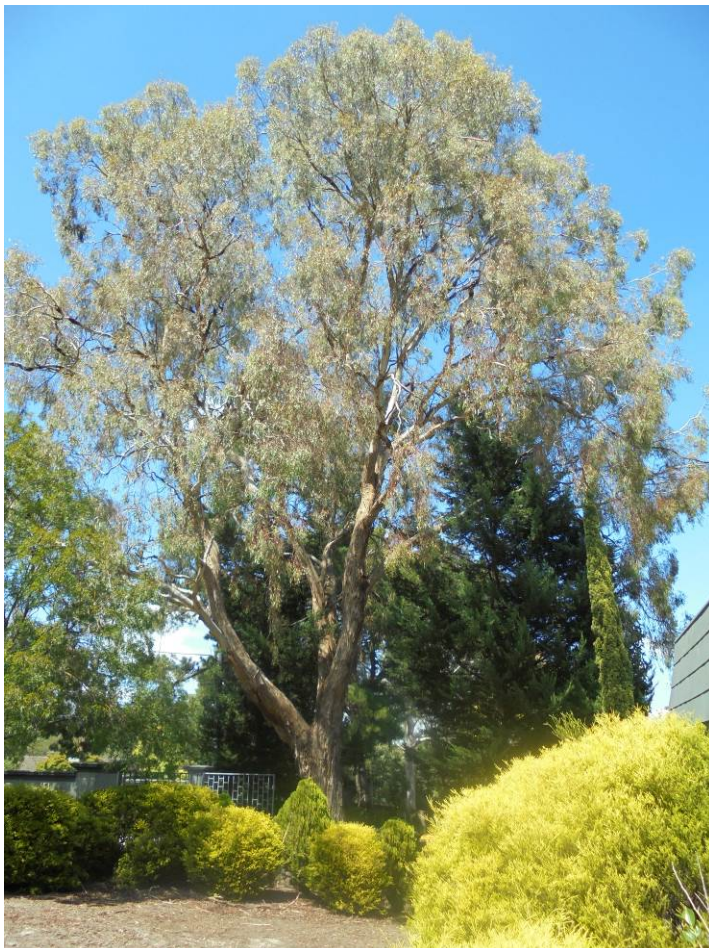
*Figure 4: Shows the relative size, condition and location of tree 4, a Yellow Box (Eucalyptus melliodora) of high arboricultural value.*

- It was recommended that the excavation of the 3m deep basement adjacent to Tree 4 must not occur beyond the proposed alignment as stipulated in the ground Floor Plan, TP-04, dated 21/06/2016.

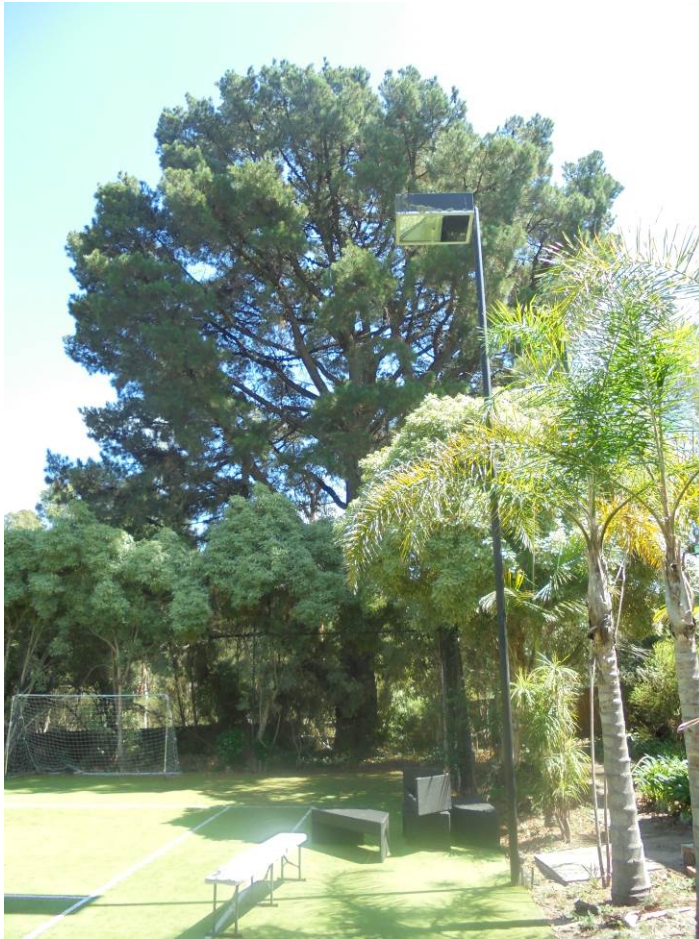
*Figure 5: Shows the relative size, condition and location of tree 25, a Monterey Pine (Pinus radiata) of moderate arboricultural value. The tree was a prominent specimen within the western extent of the site.*

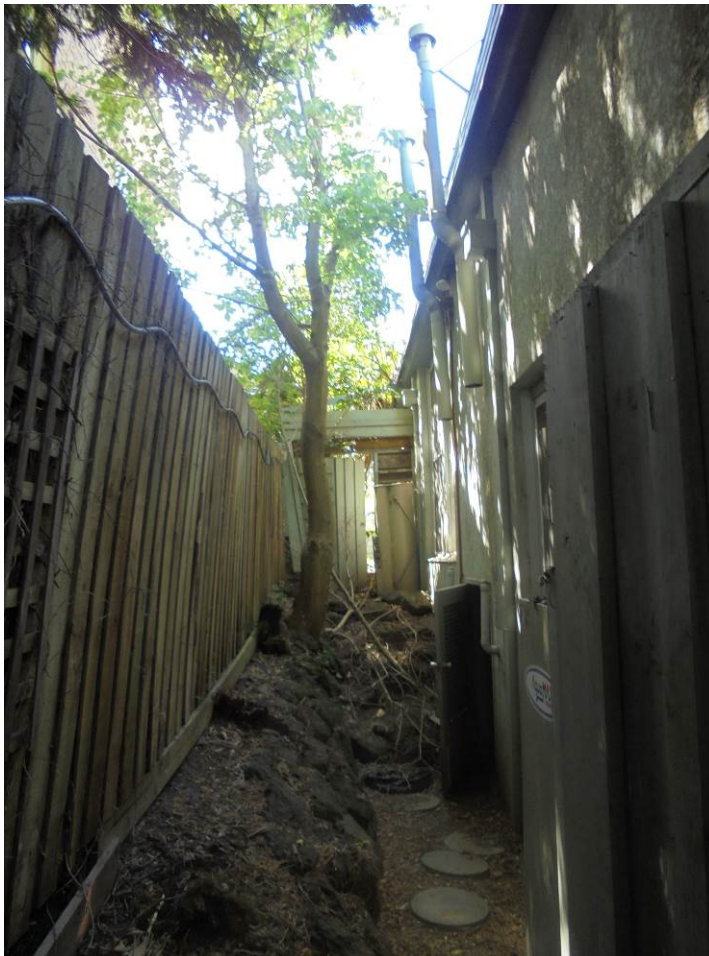
*Figure 6: Shows the existing conditions along part of the northern boundary and tree 34, a Box Elder (Acer negundo). Where the alignment of the rock retaining wall is maintained within new designs, the impacts to the trees 33, 34 and tree group 4 would be minimal.*

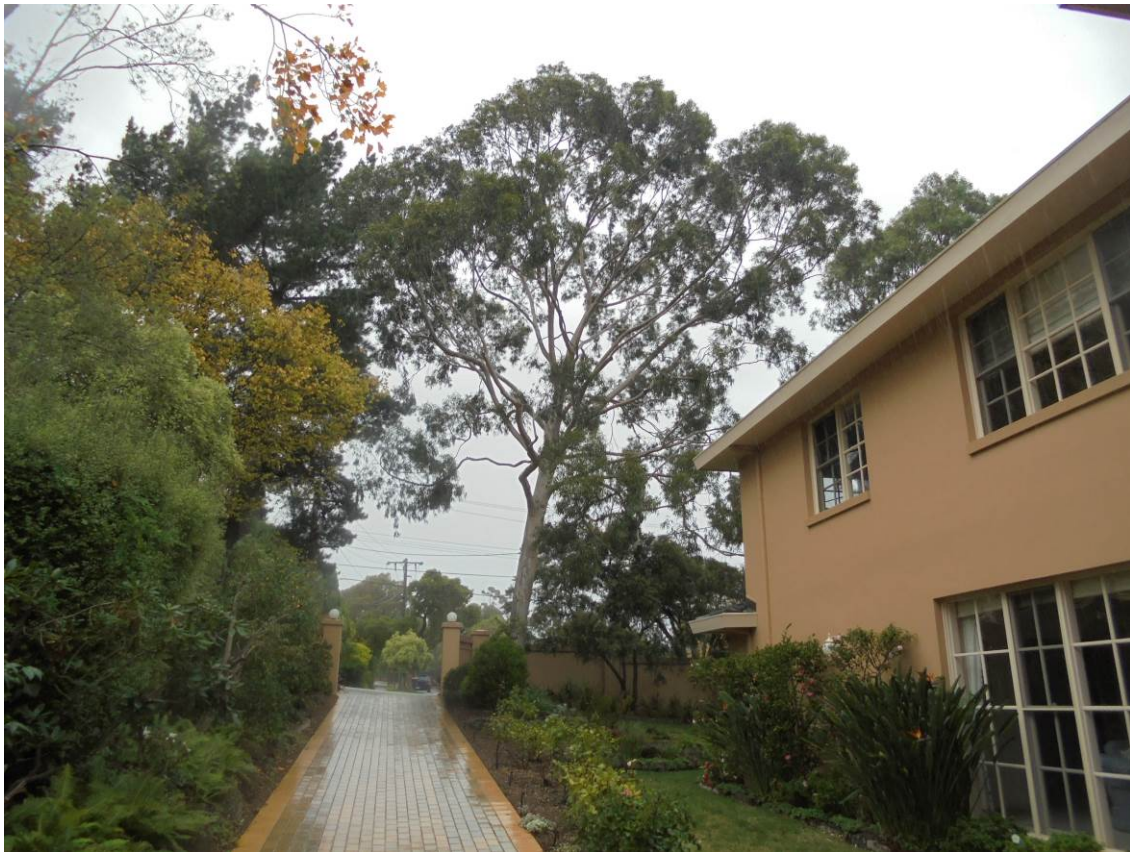
Figure 11: Shows the existing conditions along the existing driveway and the relative size, condition and location of tree 38, a Lemon-scented Gum (*Corymbia citriodora*) of high arboricultural value.

- It is recommended Modify the design, so the retaining wall alignment, including drainage is no closer than 5m on the western side from tree 38. The 7.3m retaining wall alignment to the south of the tree can be maintained.

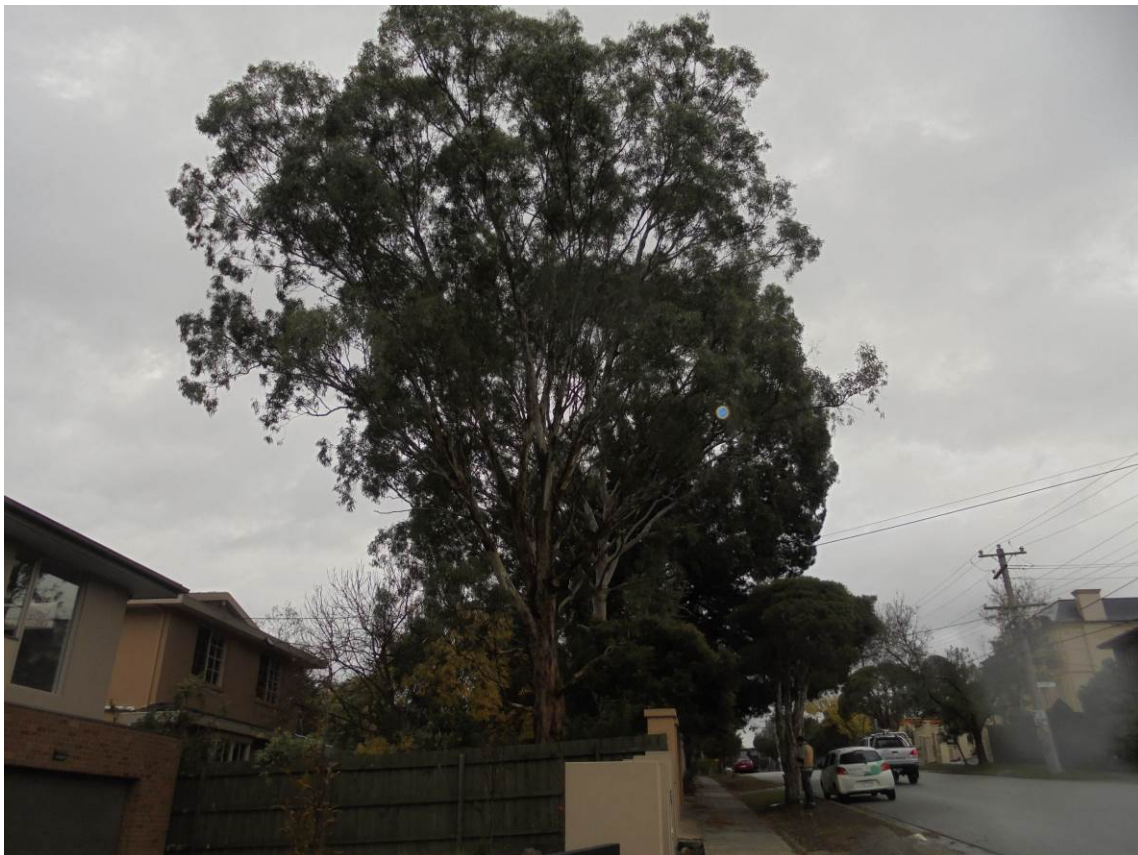
Figure 12: View to the north showing the relative size, condition and location of tree 40, a Yellow Box (*Eucalyptus melliodora*) of Moderate arboricultural value.

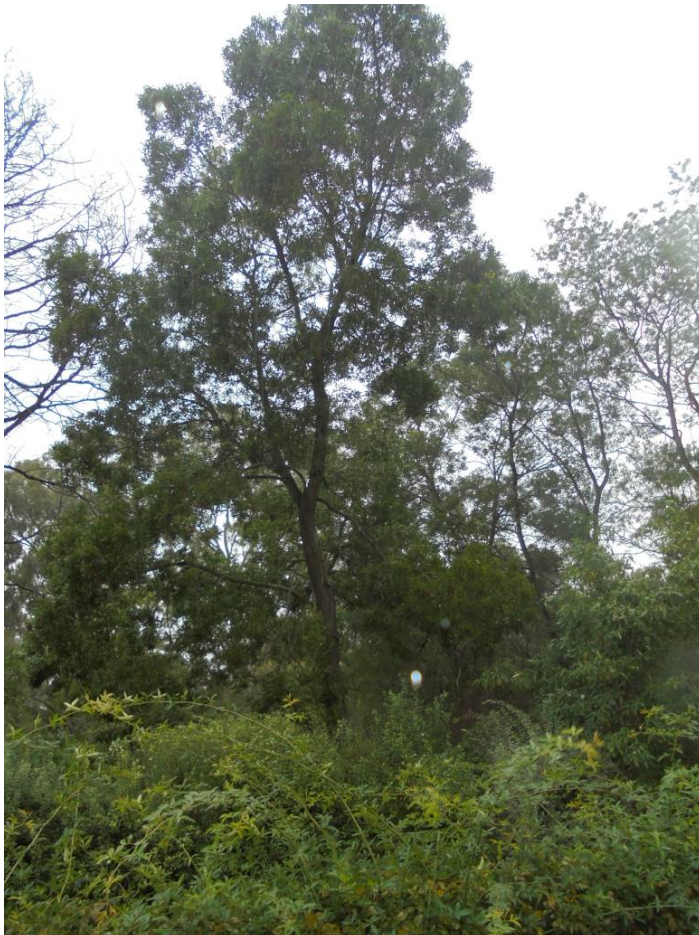
*Figure 14: Shows the relative size, condition and location of tree 47, a Blackwood (Acacia melanoxylon). The tree should be conventionally surveyed to determine its exact location.*

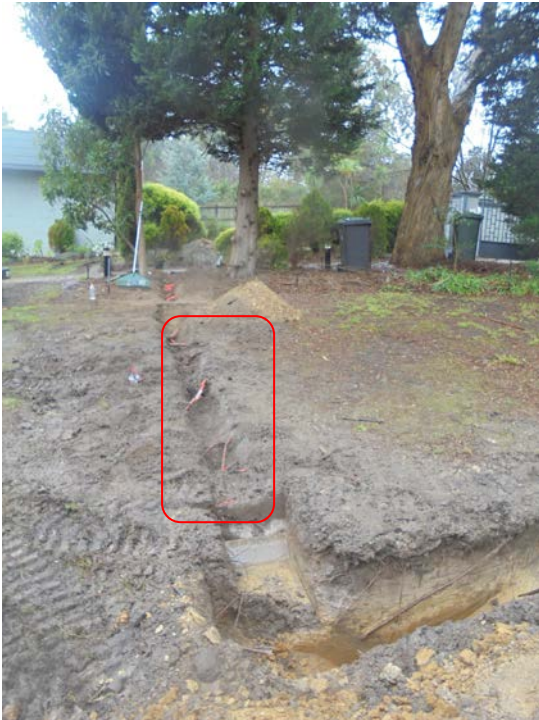
**Above left:** View to the north showing the trench on the western side of the tree. The Leyland Cypress and Brush Box trees can be seen on either side of the trench with the Yellow Box to the right of the image. The majority of Yellow Box roots were concentration in area indicated by the red rectangular box.

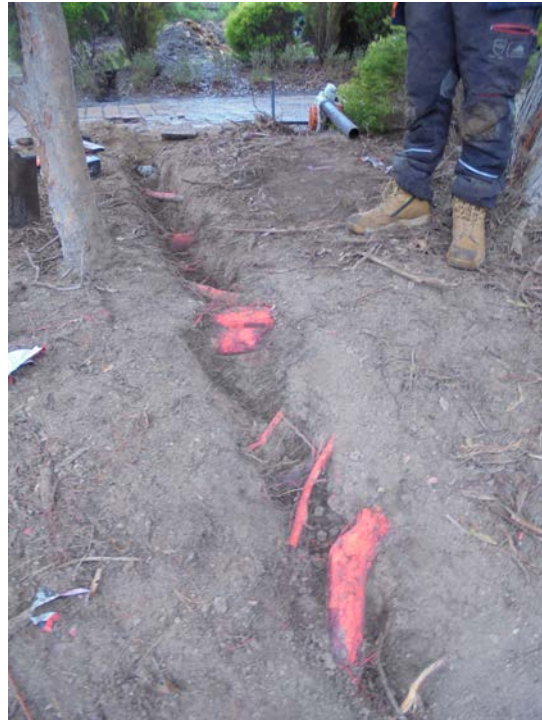
**Above right:** View to the north showing the trench alignment adjacent to the Leyland Cypress and Brush Box. These roots were mostly attributed to the conifer.

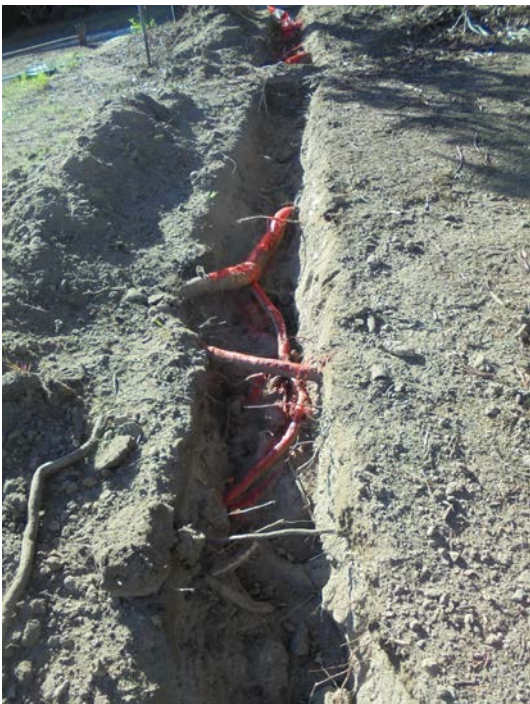
**Above Left:** View to the western trench showing a closing view of the roots from the Yellow box.

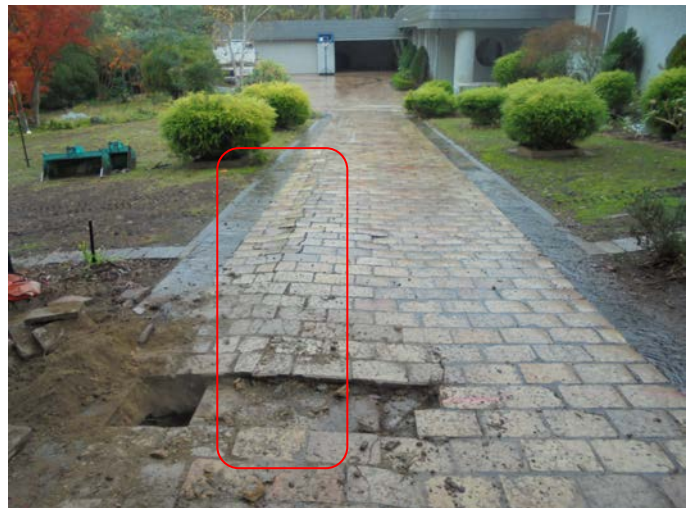
**Above Right:** View of the existing driveway to the west. The heave caused by the root of the Yellow Box is shown within the red rectangle.

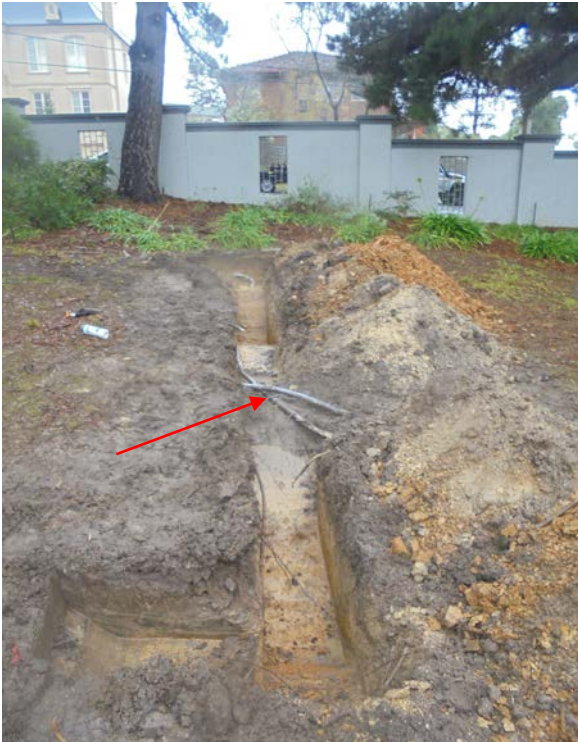
**Above left:** View to the east showing the southern trench alignment. Two deep excavation were carried out exposing two roots extending from the Pine tree (as indicated by arrow).

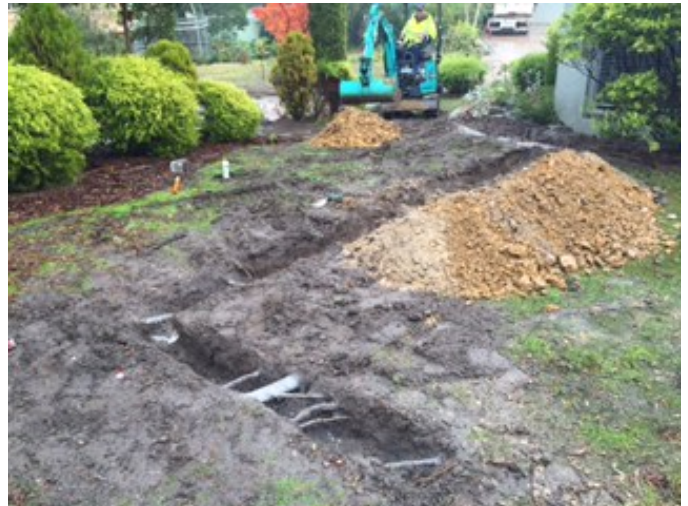
**Above Right:** View showing the roots exposed at the eastern end of the northern trench. These roots likely extended from the Golden Elm located on the eastern boundary, 5m away.

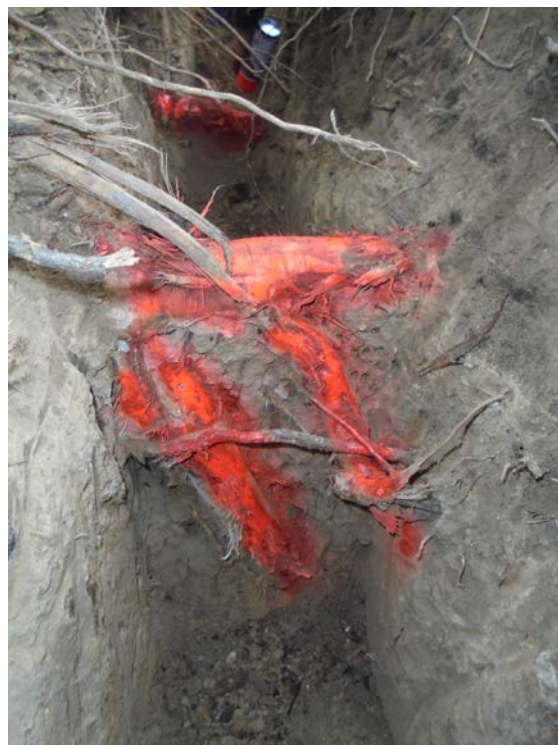
**Above Right:** View of a 130mm root with two sinker roots extending deeper into the soil profile.

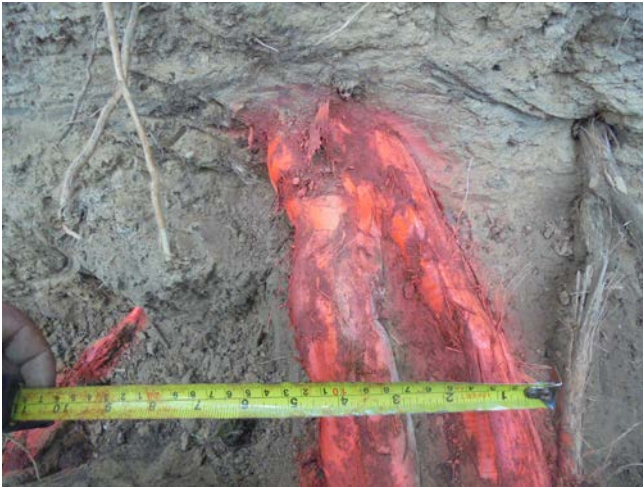
**Above left:** Showing an exposed root of 110 mmØ within the western trench.

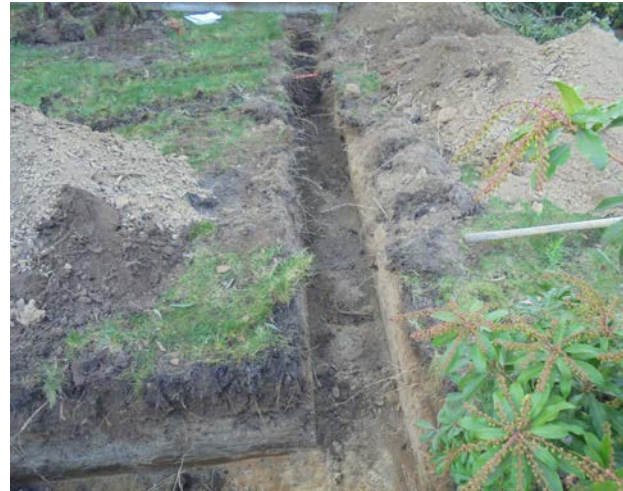
**Above right:** View to the east showing the southern trench alignment. No roots from the Lemon-scented Gum were noted within the trench alignment. Pink line indicates copper water or gas pipe.

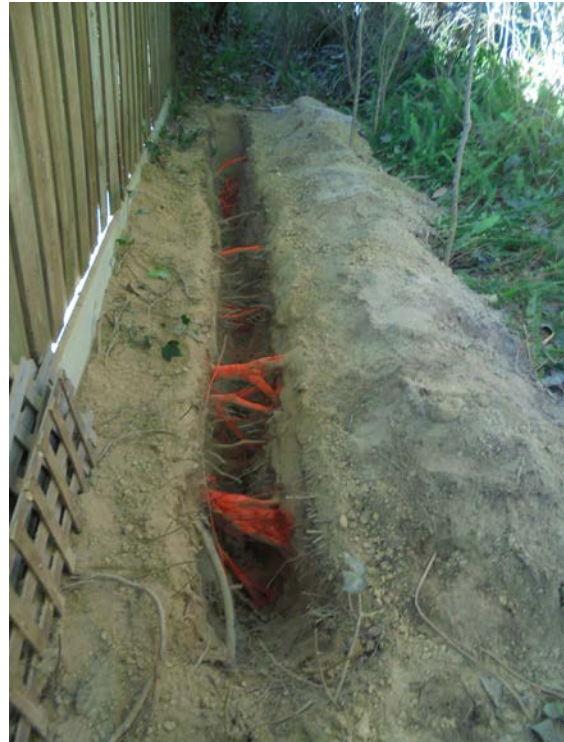
**Above right:** View to the east showing the trench alignment and proximity to the common boundary. All exposed roots were located within the top 500mm soil profile.

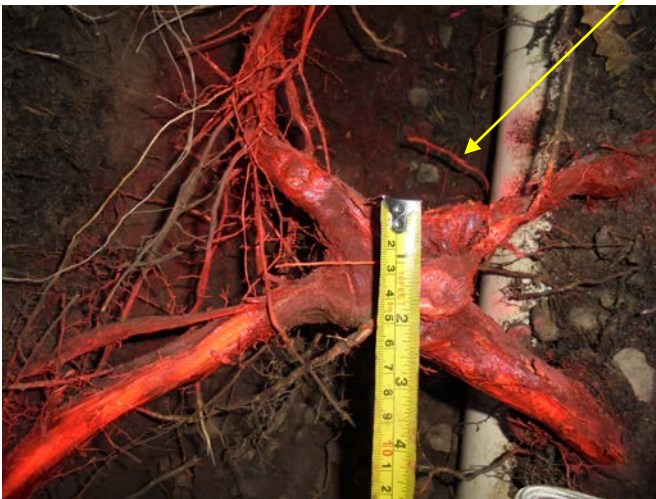
**Above Left:** Shows a branching root of 60 mmØ located adjacent to the group of conifers.
