Atherton Road Reconstruction Works – Street Tree Information

MAP - Tree Removals, Replacements and Further Assessment.

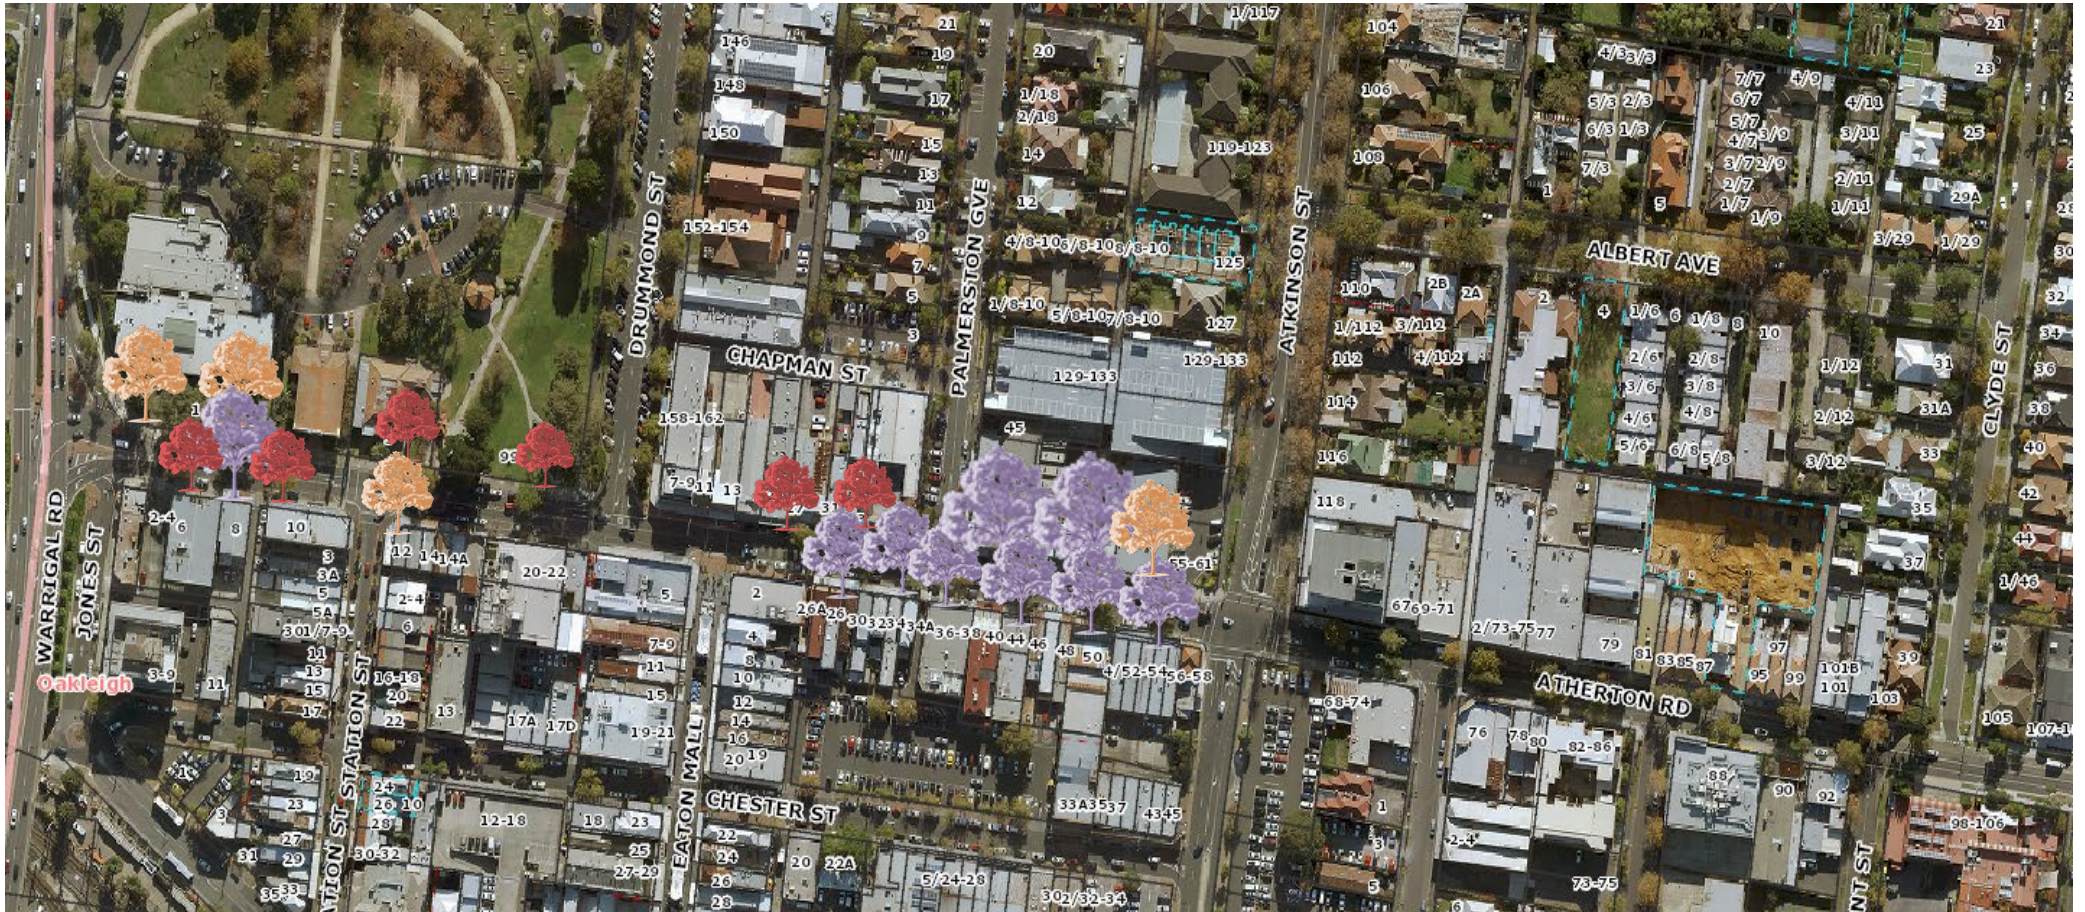
The map below details the tree removals, replacements and trees that require further assessment.
