ARBORICULTURAL REPORT

PROPERTY ADDRESS: 3 Katandra Court, Mount Waverley, VIC
Client: Brett Trevethan
Architect: RNB Design

Our Ref: PSY/2017/0928
 Date of Report: 28/09/2017
 Tree Inspection: **28/09/2017 and 22/11/2017** by Dr Peter Yau

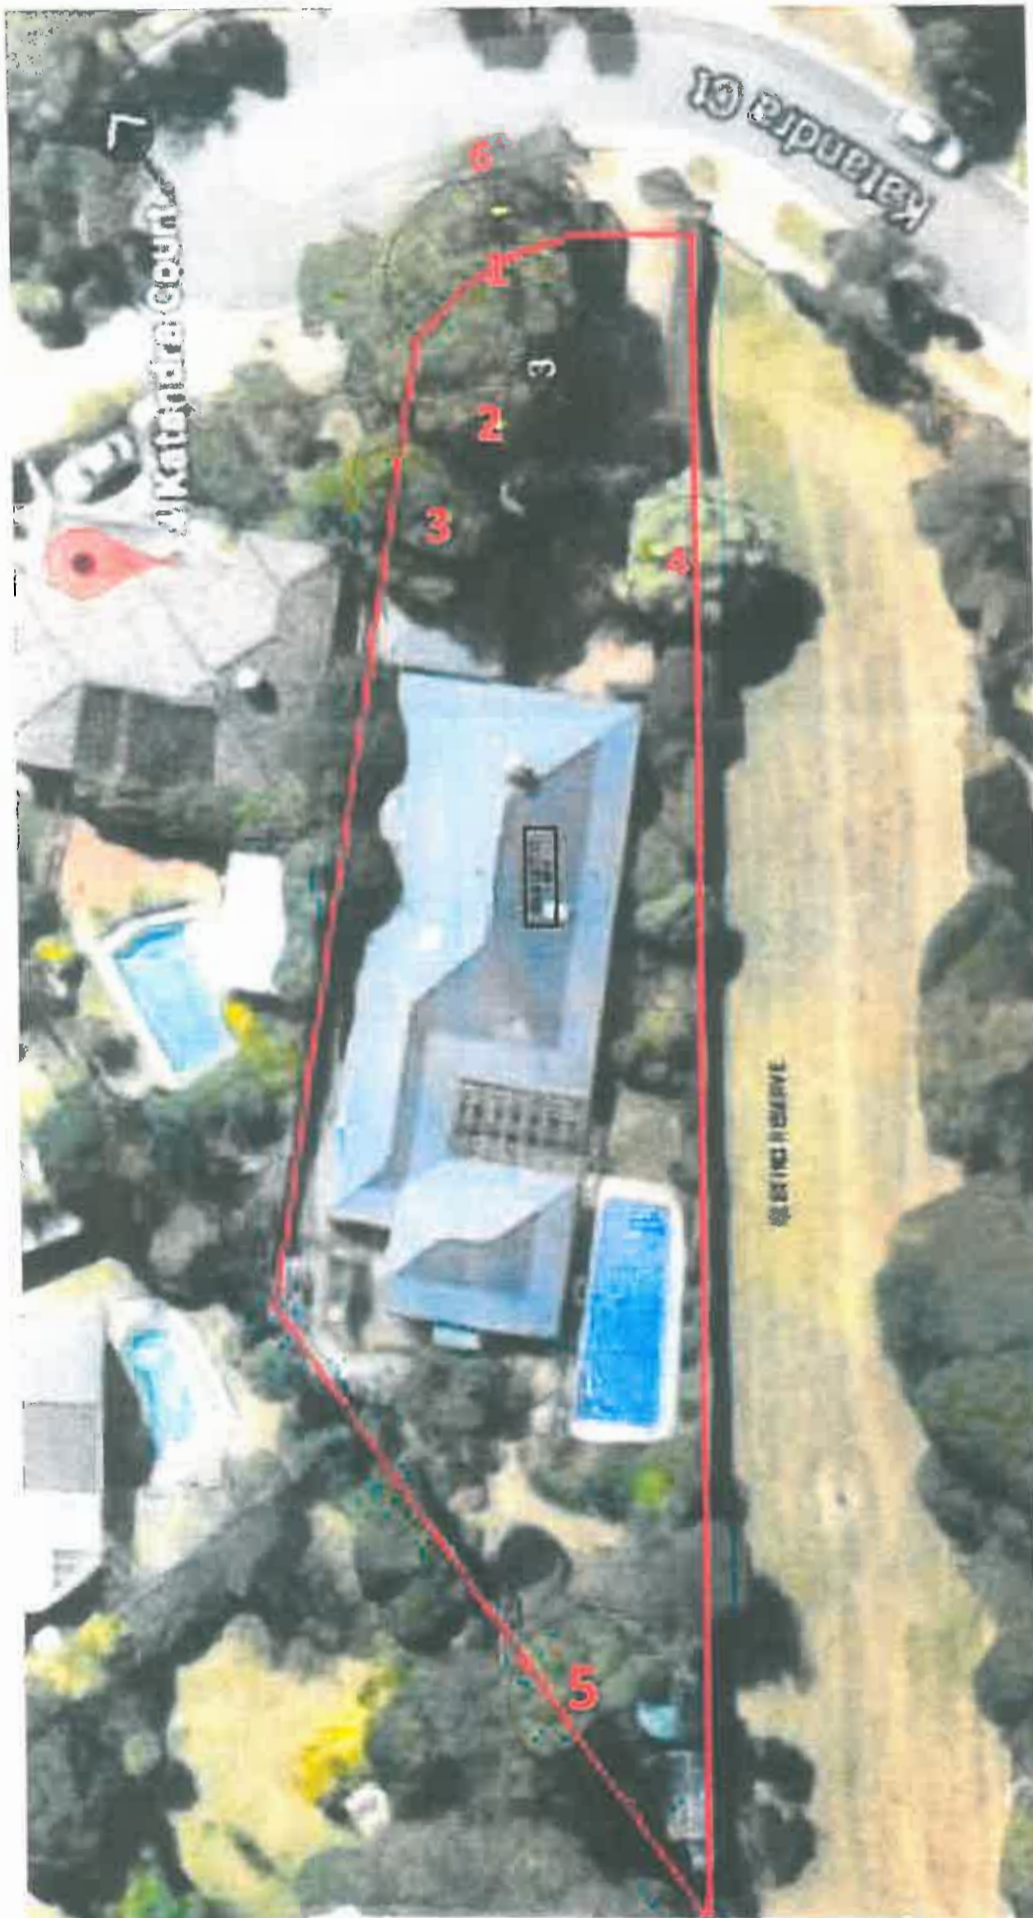
TREE 2 - *Liquidambar styraciflua* →

Tree-2 had leaf spot fungal infection first observed when inspected in Sept 17. When re-inspected in November the new spring season foliage has shown no more new signs of such leaf spot symptoms indicating the tree is now in good health with thick dense foliage canopy. The tree is still considered of Medium retention value, meaning removal is recommended because the tree is considered too close to the building front unit with encroachment over 10% allowed limit. However if council refuses to grant removal permit, then the tree has to be retained and **the construction of the front unit closest to this tree MUST be tree sensitive, using screw piles supporting footing system with above-grade edge beams, with no site cut/fill, no excavation, no retaining wall etc. Otherwise a root exploration trenching investigation will be necessary.**

Tree No. 2
Species: *Liquidambar styraciflua* (Liquidambar)
DBH: 480 mm
TPZ: 5.75m radius
SRZ: 2.5m radius
Canopy: 12m
Height: 14m
Health: **Fair in Sept** – leaves suffering from leaf-spot fungal attack and leaf margin necrosis – photo1
***Good in Nov** - New spring season foliage when inspected on 22/11/17 revealed no new signs of any leaf-spot symptoms in the new leaves on this tree in this spring season. The tree canopy foliage density is dense healthy and in good health.
Photos2-3 refer.

Retention: **Medium – if removal needs VPO permit**
Impact: **Tree too close to front Unit – recommend to remove tree as first option**
IF council refuses to grant removal permit, then the construction of the front unit closest to this tree MUST be tree sensitive, using screw piles supporting footing system with above-grade edge beams, with no site cut/fill, no excavation, no retaining wall etc. Otherwise a root exploration trenching investigation will be necessary.

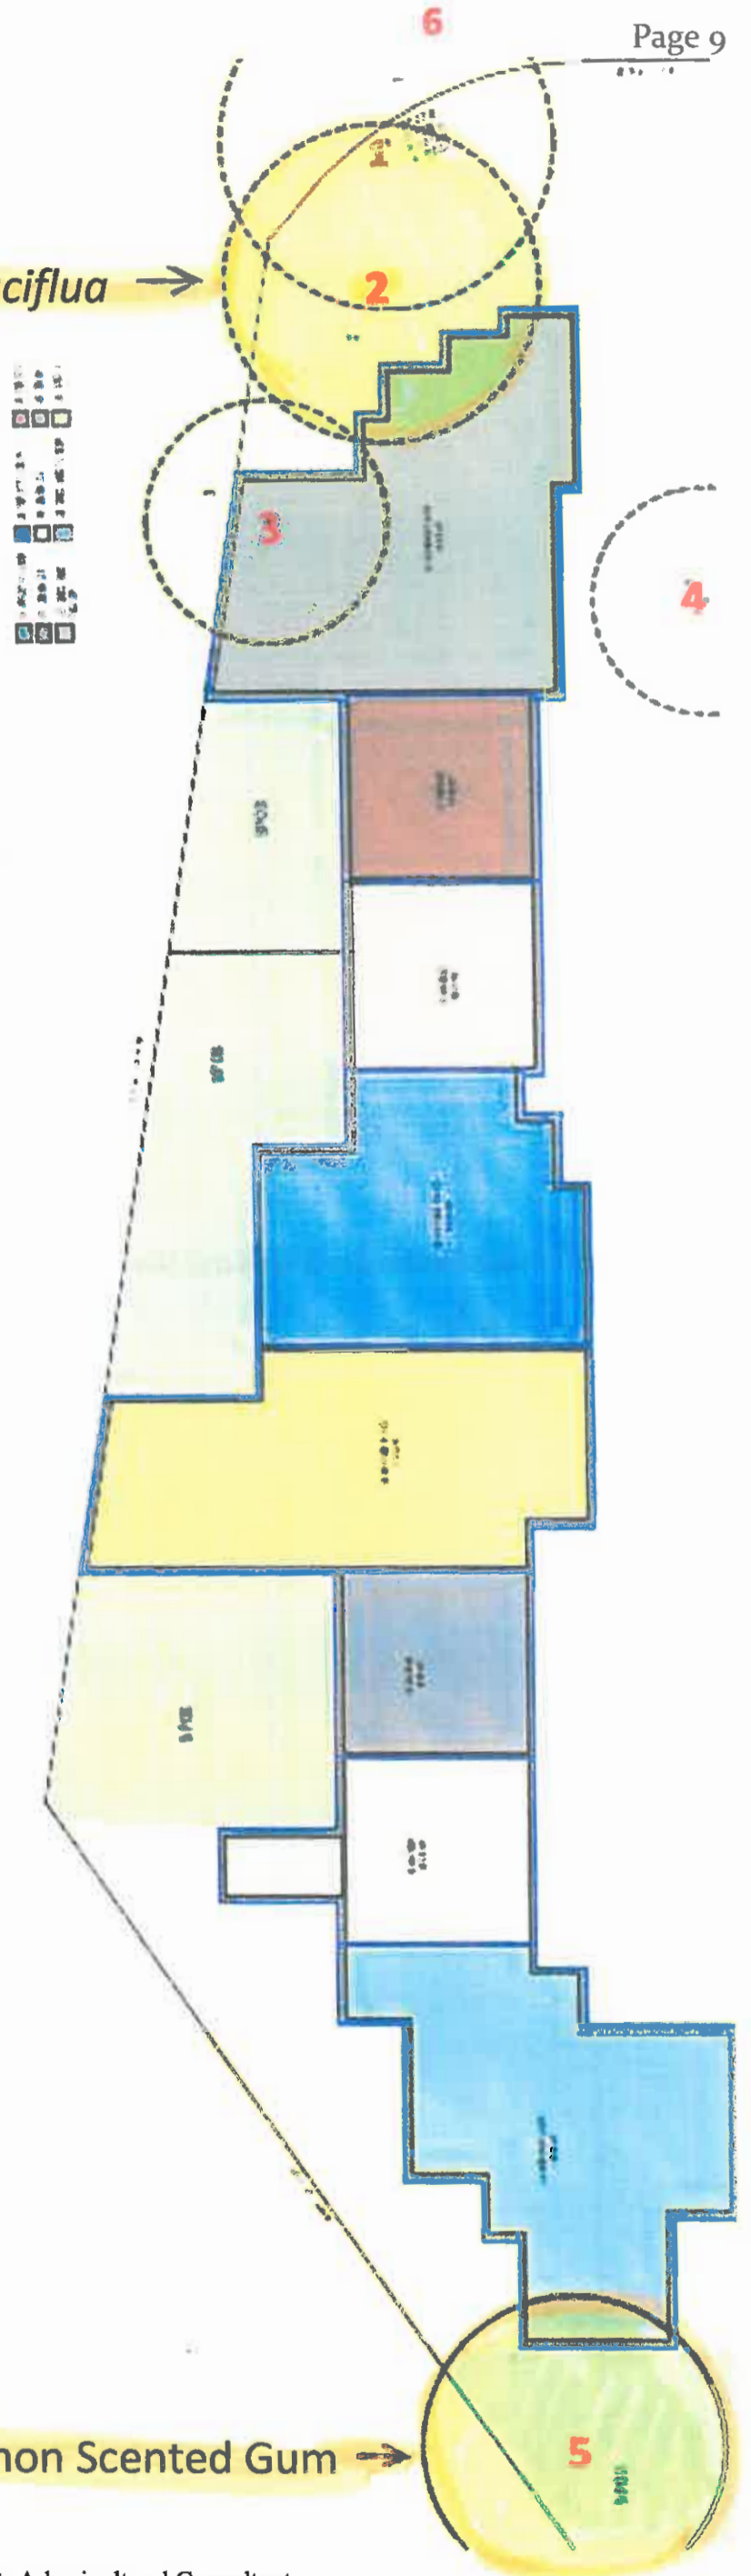
TREE 5 - *Corymbia citriodora* (Lemon Scented Gum) →

Tree-3 and Tree-4 are under 10m and removal does not trigger the council VPO Permit requirement. Tree-5 has suffered massive limb breakage and limb drop leaving a huge open break wound in the tree trunk and the tree canopy HALVED by the developer next door doing massive canopy pruning leaving the tree in half canopy P-shape only.

Tree No. 5
 Species: *Corymbia citriodora* (Lemon Scented Gum)
 DBH: 500mm
 Canopy: 12m / 6m (asymmetrical shape)
Height: 16m
 Health: Good
 Structure: **Poor – large branch had broken off leaving HUGE open wound in main trunk – see photo**
 Form: **Poor – half of tree canopy cut off by adjoining property development, canopy shape becomes P-shape with only half canopy - unbalanced and asymmetrical shape – see photo**

Significance: Native greenery tree – a **HIGH RISK** limb dropper gum tree species
 ULE: Medium (depends on future maintenance)
 Retention: **Low – removal recommended - needs VPO permit – tree taller than 10m**
 Impact: **Tree too close to rear unit – will encroach tree TPZ – tree not worth retention**

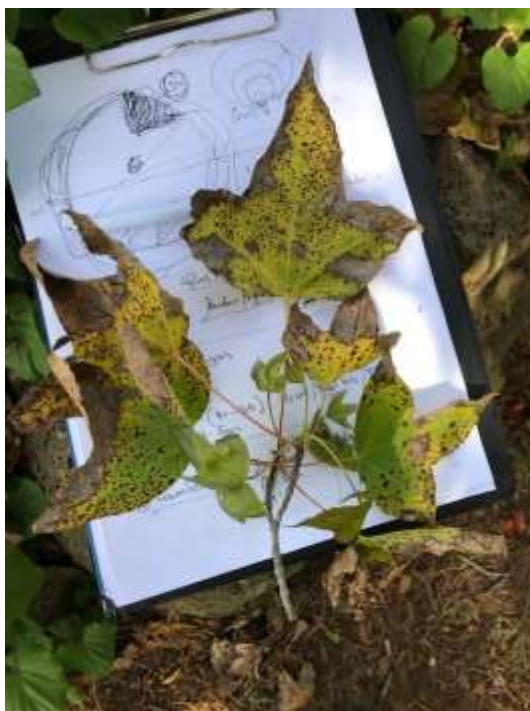
Photo-1 Last season Leaf Spots and margin necrosis **Photo-2** New Season Foliage – No More Leaf Spots – healthy leaf

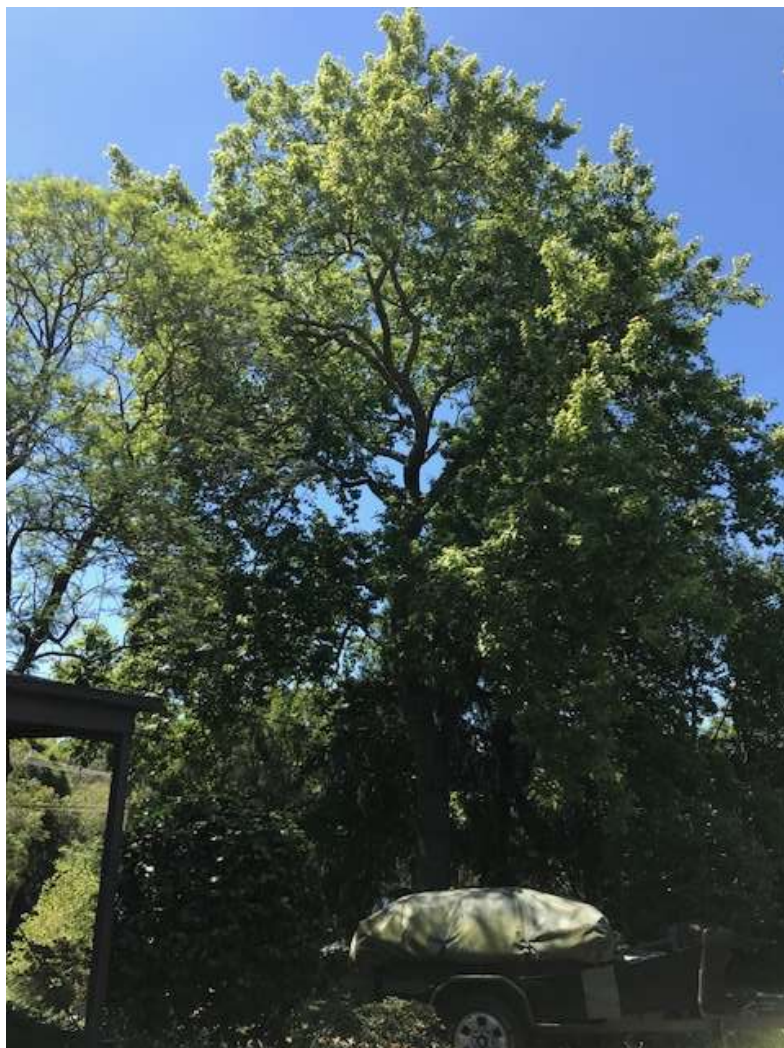
Photo-3 Tree in good healthy condition with thick dense foliage canopy (22 Nov 17)

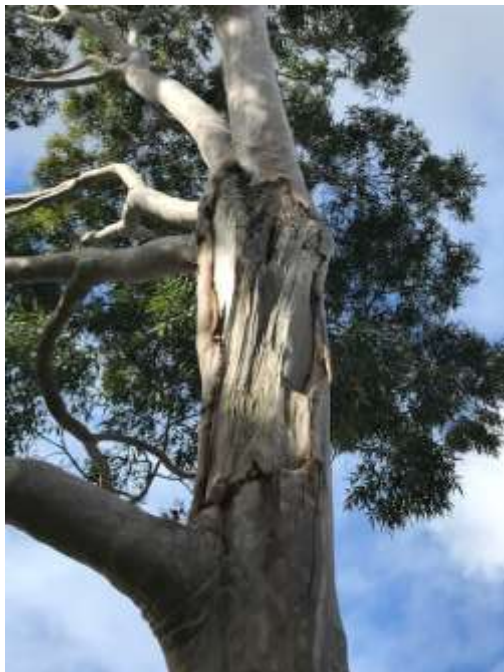
Tree-5 Large wound by limb breakage

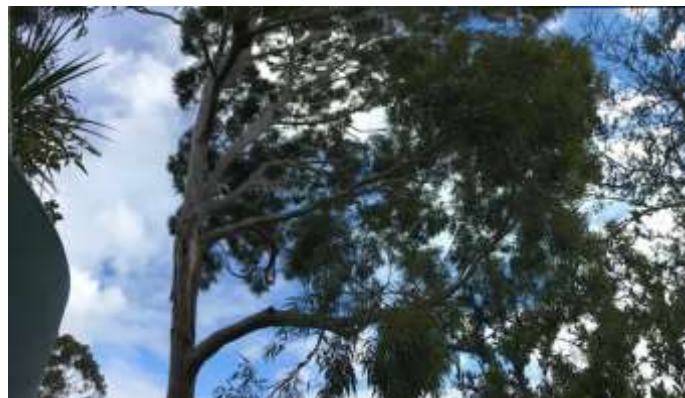
Tree canopy P-shape due to unbalanced canopy lopping
