Attachment 1 - 12 Calderwood Avenue, Wheelers Hill

BAXTER ECOLOGY & ASSOCIATES

Tree Health & Risk Assessment 12 Calderwood Ave, Wheelers Hill

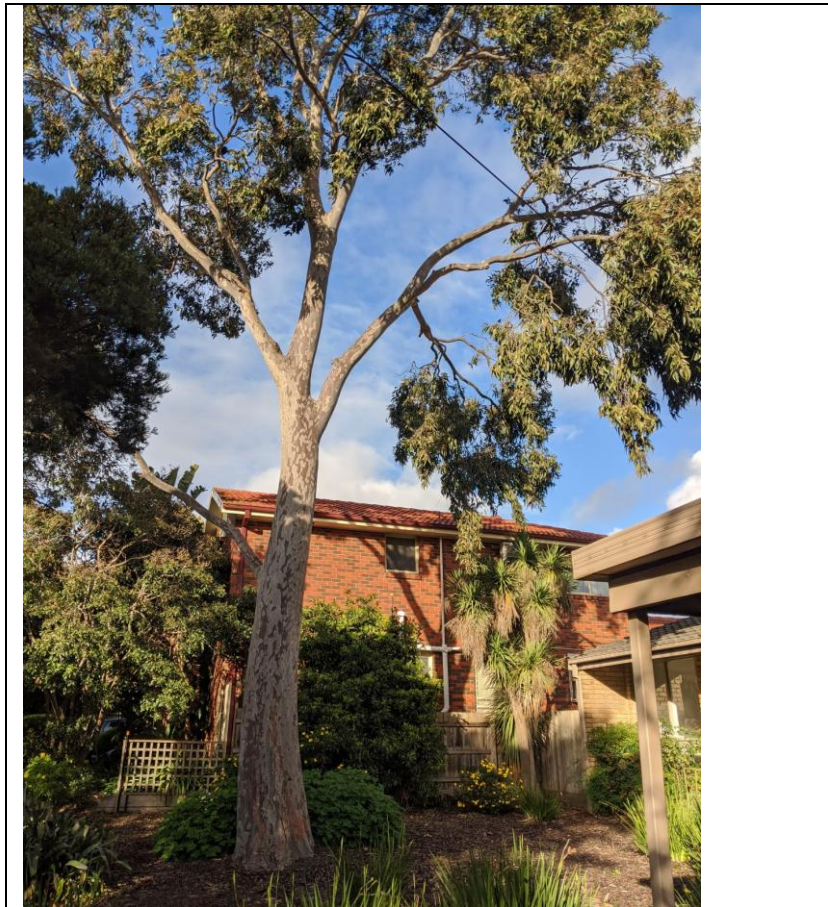
- 4.4. Minor deadwood was observed throughout the inner and upper crown. Some historical pruning exhibit good cambial healing at pruning locations.
- 4.5. Minor limb failure is evident in the crown

- 4.8. There is minor overhang of the outer canopy towards the title boundary to the east, carport to the west and the front of the dwelling to the south.

Image 1: Tree 1 with neighbours dwelling to the east. Good leaf density heavily laden with fruit in southern hemisphere.

- 6.1. **Tree 1** – The tree is a healthy specimen and presents a Low Risk within the context of its location. It is recommended that the tree be maintenance-pruned with light weight reduction and re-inspected at 2-3 year intervals
- 6.2. **Tree 2** – The tree is a healthy specimen and presents a Moderate-Low Risk within the context of its location however the proximity to the east title boundary and history of limb failure supports consideration for removal.
 - 6.2.1. Pruning and on-going assessments of the tree may result in reducing the risk to an acceptable level however the tree is early mature and likely to double in bio-mass continuing to require a higher than reasonable level of maintenance.
- 6.3. If Tree 2 was approved for removal by Council it is recommended a replacement canopy tree be planted in accordance with the objectives of the VPO

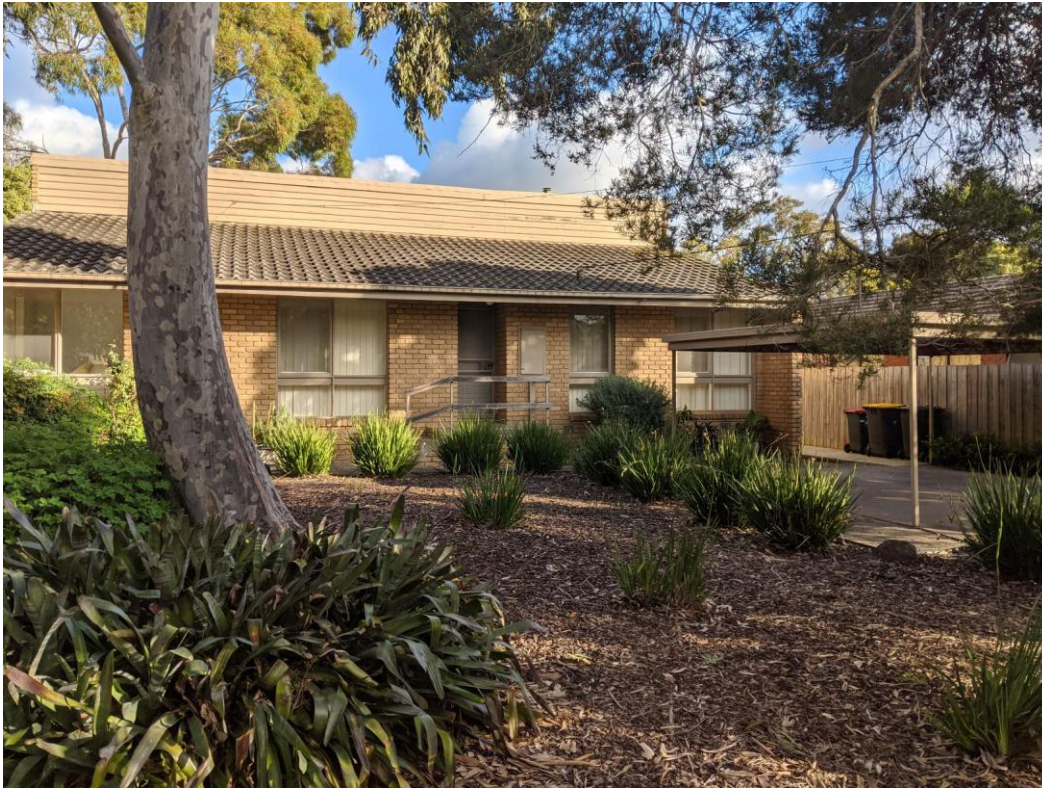
- 4.1. **Tree 1** is a magnificent specimen with excellent form. It is estimated as being approximately 40-50 years of age. The trunk has a sway, leaning to the east but correcting at approximately two metre visible in image 2 below. There was no observed ground-heave or other signs of instability of the root plate.

Image 2: Tree 1 showing sway in lower trunk and exclusion landscaping with perimeter planting adjacent to carport and pathway to the front door.

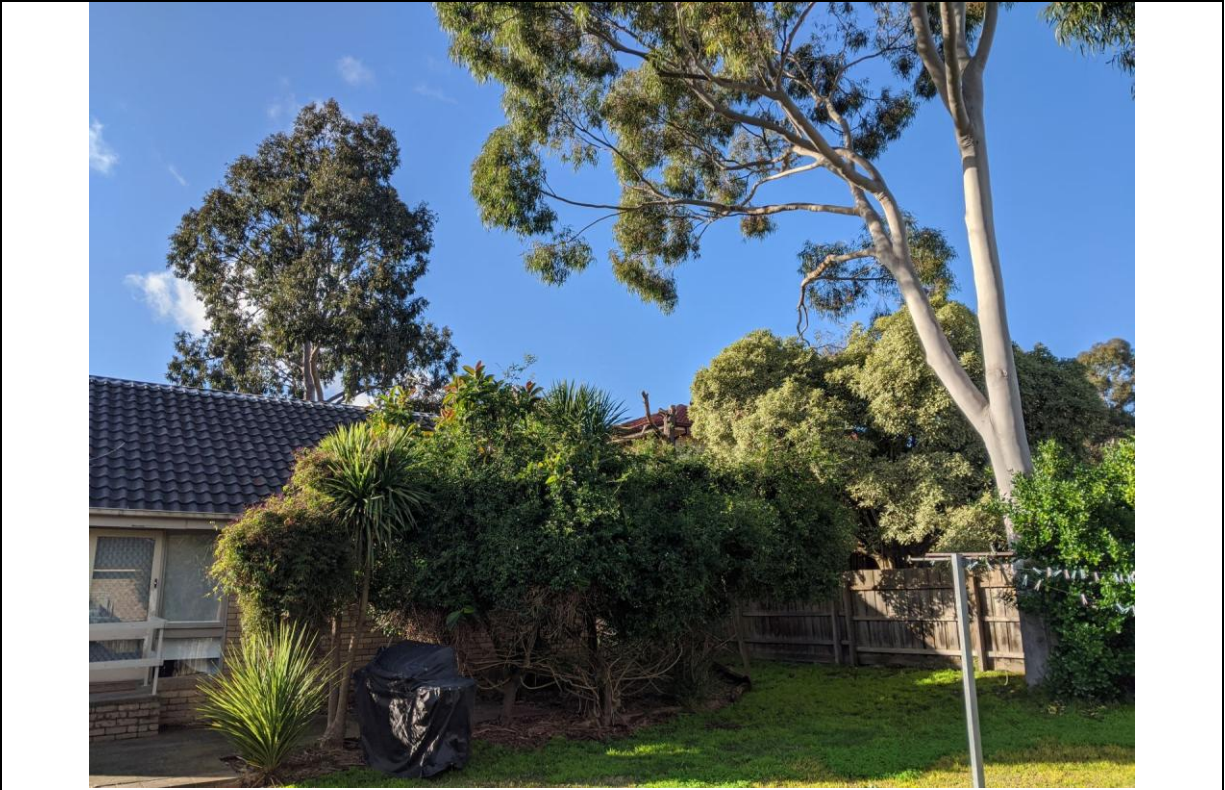
- 5.1. **Tree 2** is a healthy specimen with an asymmetrical crown evidenced by a sub-dominant leader growing towards the dwelling (Image 3).
- 5.2. The tree is free of defects and exhibited good cambial healing at old pruning points

- 5.3. Some branch failure was evident in the crown consistent with reports from the property owner and neighbours
- 5.4. The tree is located less than 2m from the east title boundary overhanging a large *Pittosporum euginoides* and small garden shed located in the neighbouring yard.

- 5.6. Minor deadwood was observed throughout the crown.
- 5.7. The branching network is elongated, laden with leaves and fruit and susceptible to dominant north west winds.

Image 3: Tree 2 with neighbours dwelling to the east. Exclusion landscaping and planting adjacent to back door. Clothes-line in foreground (right). Asymmetry with sub-dominant leader growing to the north with good leaf density heavily laden with fruit in northern hemisphere.
