ARBORICULTURAL REPORT

1494 – 1496 NORTH ROAD, CLAYTON

April 2020

Revised July 2020

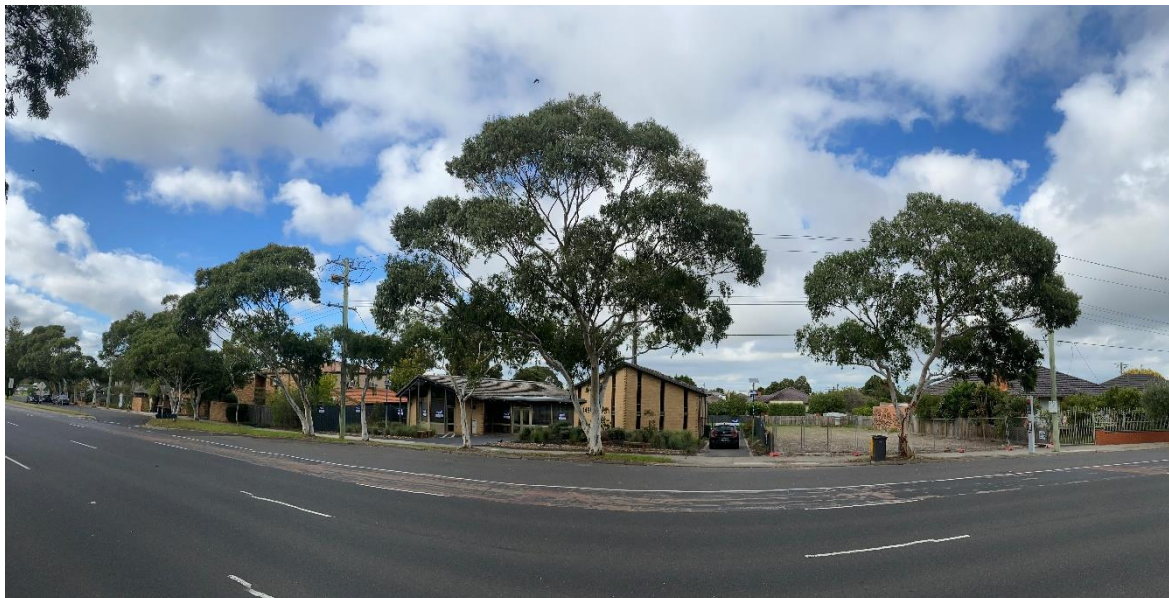
Figure 1: Front of site showing Trees 1 – 6 (right to left)

- 5.5 The TPZ of Tree 1 does not enter the site. This tree is therefore unlikely to be impacted by the proposed development.
- 5.6 It is proposed to widen the existing crossover resulting in it being located approximately less than 500mm from the base of Tree 2, a large Wallangarra White Gum street tree. This is likely to necessitate removal of the tree. This will need to be negotiated with the Responsible Authority. Given the presence of street trees within the road reserve adjacent to the site, it is unlikely that a crossover of this width could be accommodated without the removal of at least one tree.

- 5.7 To retain the tree, a non-destructive root investigation would be required, not only to determine how close the proposed crossover could come to the tree without impacting major roots, but also to determine the impact that the ramp, pedestrian path, masonry fence, booster cupboard and likely landscape works will have on the tree. Current plans indicate that the total encroachment of all these elements is in the vicinity of approximately 25.4% including 10% by the basement ramp, 0.6% by the building and the 2.9% by the pedestrian entry path.

- 5.8 Approximately 3.5% of the TPZ of Tree 3 and 4.3% of the TPZ of Tree 4 enter the subject site. It is therefore unlikely that the proposed development will negatively impact these trees. Gas and water meters are proposed within the TPZs and service lines to these meters will need to be installed either using hydro-excavation or by boring under the root plates.

- 5.9 Approximately 15.1% of the TPZ of Tree 5 enters the subject site. Masonry fences and a substation are located within this area. The proposed substation encroaches approximately 9.4% into the TPZ. Provided footings for the masonry fences are engineered to bridge any roots greater than 40mm revealed through exploratory digging and landscape areas within the TPZ are maintained at existing soil levels (unless exploratory digging reveals no roots greater than 40mm will be impacted), the impact of encroachment will be restricted to that of the substation. This complies with AS4970-2009.

- 5.10 All service lines leading into the substation must be installed using either hydro-excavation or by boring under the root plate of the tree.
- 5.11 There are no proposed works within the TPZs of Trees 7, 8, 9 or 10 located in the neighbouring property to the south, or Tree 13 in the neighbouring property to the east. Provided landscape areas within the TPZs are maintained at existing levels, these trees are not expected to be negatively impacted.

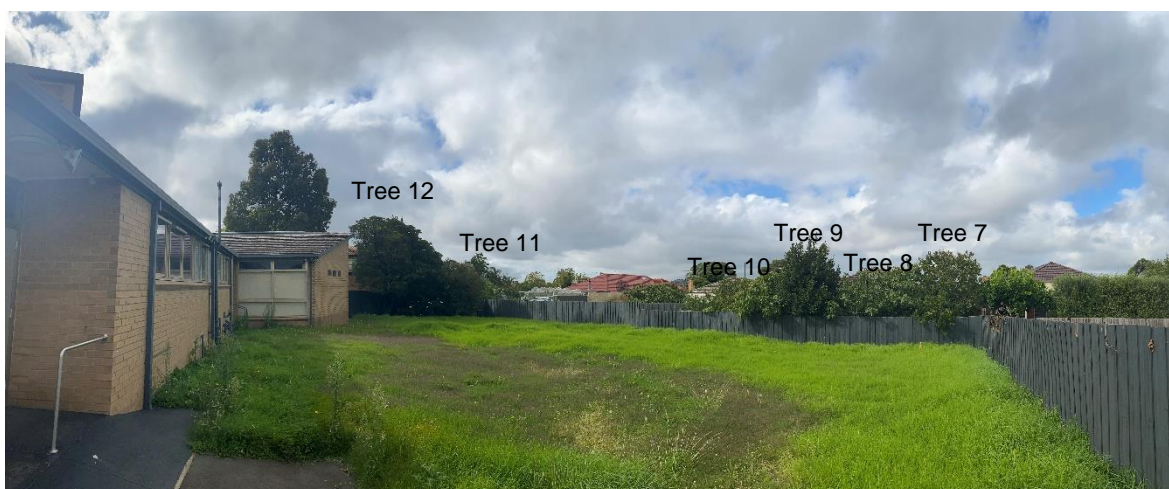
Figure 2: Rear of the site showing Trees 7 – 10 in the neighbouring property to the south and site trees Tree 11 and 12

- 5.4 The two site trees, Trees 11, an Oleander and Tree 12, a weedy Sweet Pittosporum, are of low arboricultural value with neither of them worthy of retention. Both trees are proposed to be removed.

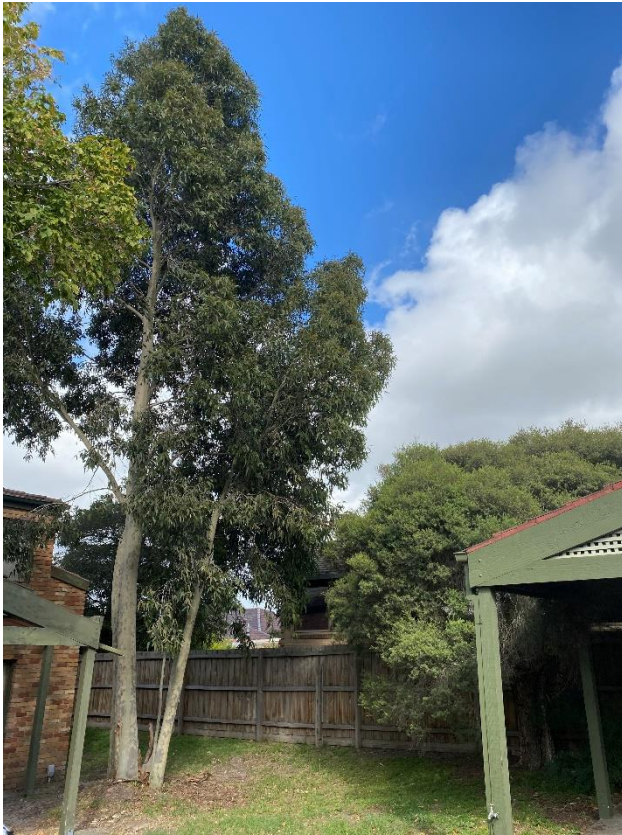
Figure 3: Trees 13 (left) and 14 in the neighbouring property to the east.

- 5.12 The basement encroaches into the TPZ of Tree 14, located in the neighbouring property to the east, approximately 18.5%. The existing brick building is currently located within this area and it is expected that the footings of this will have limited root growth from extending into the footprint. Given that the basement is proposed behind the alignment of the existing building, I do not expect it to negatively impact the long-term healthy retention of this tree.

- 5.13 If boundary fences are to be replaced, it is recommended that any section of the new fences that pass through the TPZ of trees to be retained be of light-weight construction with post holes hand dug and relocated if necessary to avoid major roots. It is also recommended that all landscape areas within the TPZ of trees to be retained be maintained at existing grades.
