Tree Removals

Infill Planting Location

Street Overview

Proposed Tree Species Options

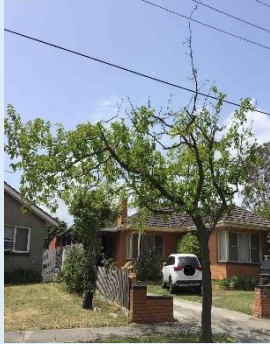
Ref No.	Street Address	Assessment Outcome	Follow Up Action	Current Tree Species	Tree Condition Assessment (*ULE <2 Years)	Tree Image
47	19 Sandgate Avenue	Tree to be removed	No replacement tree to be planted	<i>Ulmus glabra Lutescens</i>	Vigour (health) in canopy 85%. But dieback through crown. Trunk defect observed. Possible bacterial infection

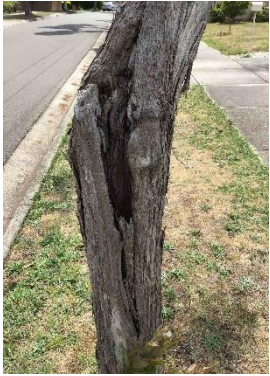
48	43 Sandgate Avenue	Tree to be removed	Replacement tree to be planted	<i>Callistemon citrinus</i>	Major decay through most of main stem

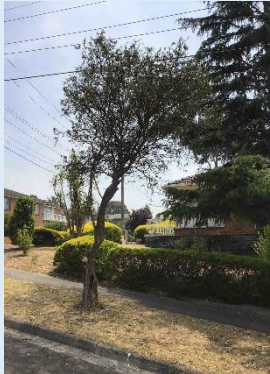
49	51 Sandgate Avenue	Tree to be removed	Replacement tree to be planted	<i>Callistemon linearis</i>	ULE <2 Years

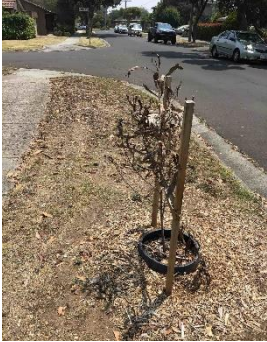
Ref No.	Street Address	Assessment Outcome	Follow Up Action	Current Tree Species	Tree Condition Assessment (*ULE <2 Years)	Tree Image
58	6 Bristol Court	Tree to be removed	Replacement tree to be planted	<i>Buckinghamia celsissima</i>	Dying

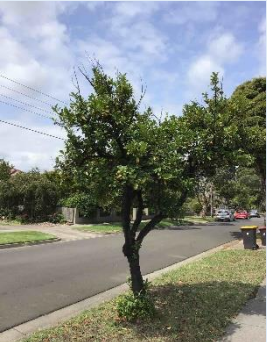
59	2 Sandgate Avenue	Tree to be removed	Replacement tree to be planted	<i>Ficus sp.</i>	Declining vigour. This species has higher potential to contribute to surrounding infrastructure damage

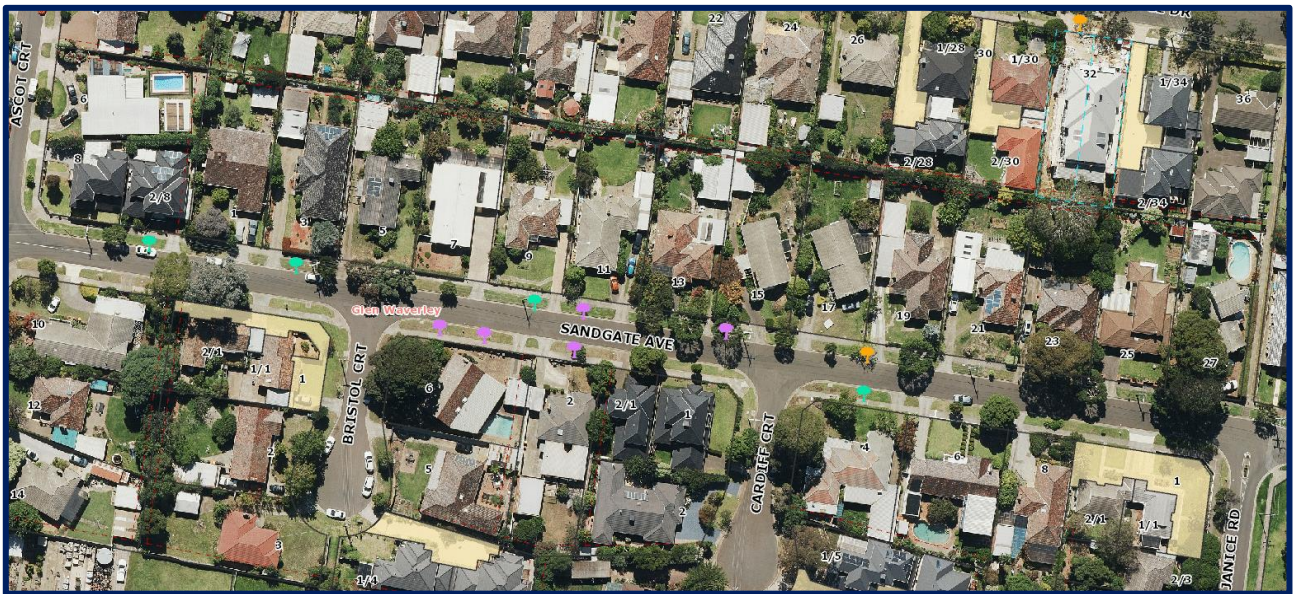
The map below details the removals, replacements and infill plantings. All other trees have been assessed as having more than 2 years useful life and will be retained.
