**Re: 1041 Centre Road, Oakleigh South
Heritage Due Diligence Assessment**

Introduction

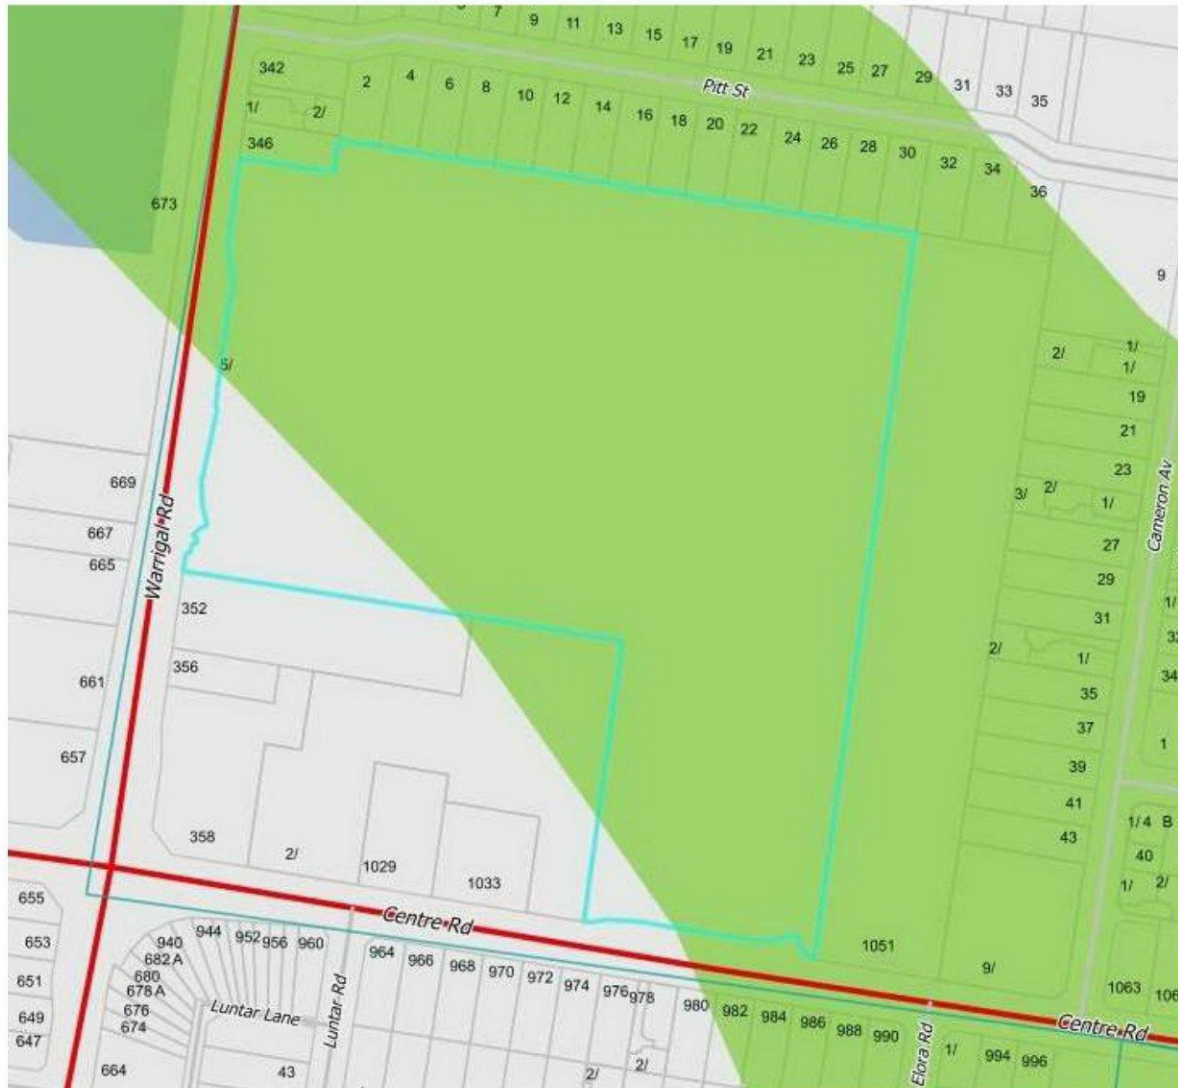
Figure 1: Activity Area with Cultural Heritage Sensitivity in green shading.

The majority of the activity area is situated on a Sand sheet landform, which is considered to be an area of “cultural heritage sensitivity” under r.41 of the Regulations (Figure 1– green shading).

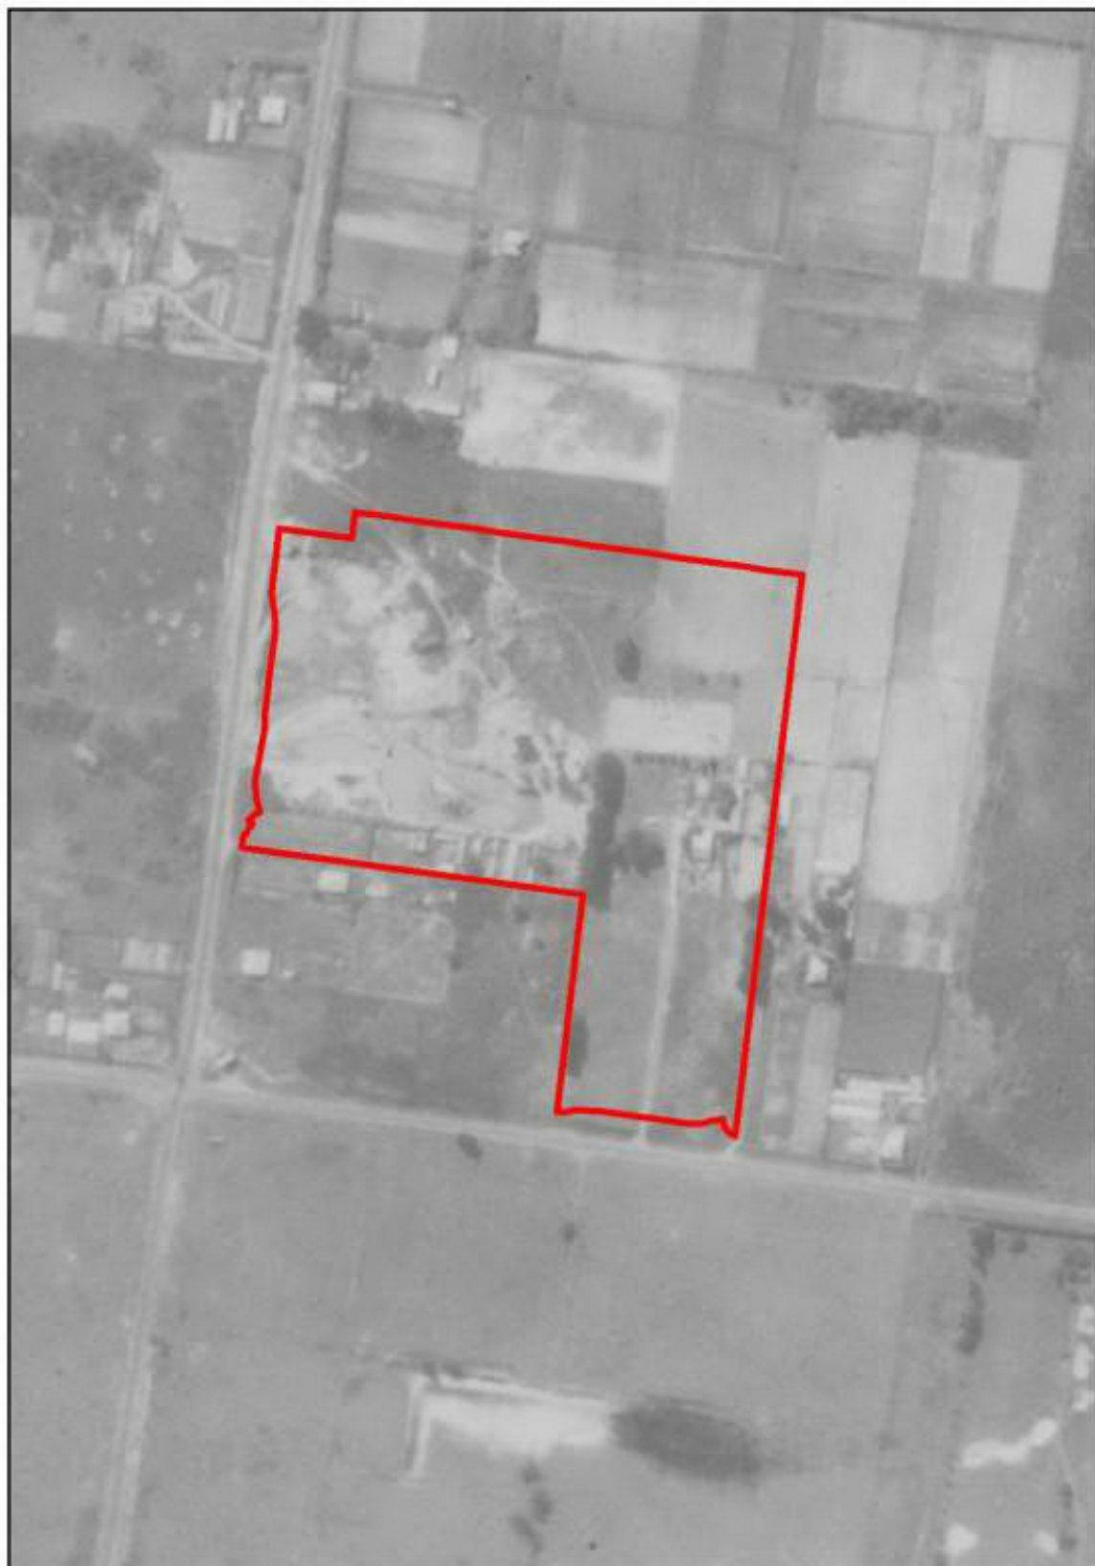
Figure 2: 1931 Aerial photograph, activity area in red.

Aerial photographs of the activity area were obtained, dating from 1931 to 2018. The earliest photograph in 1931 reveals quarry activities are taking place within the western half of the activity area, with a dwelling and sheds in the centre of the east half and vacant land either side of the dwelling (Figure 2). A row of tree plantings separates the house from the quarry to the west. The surrounding area is predominantly vacant farmland, with rural dwellings.

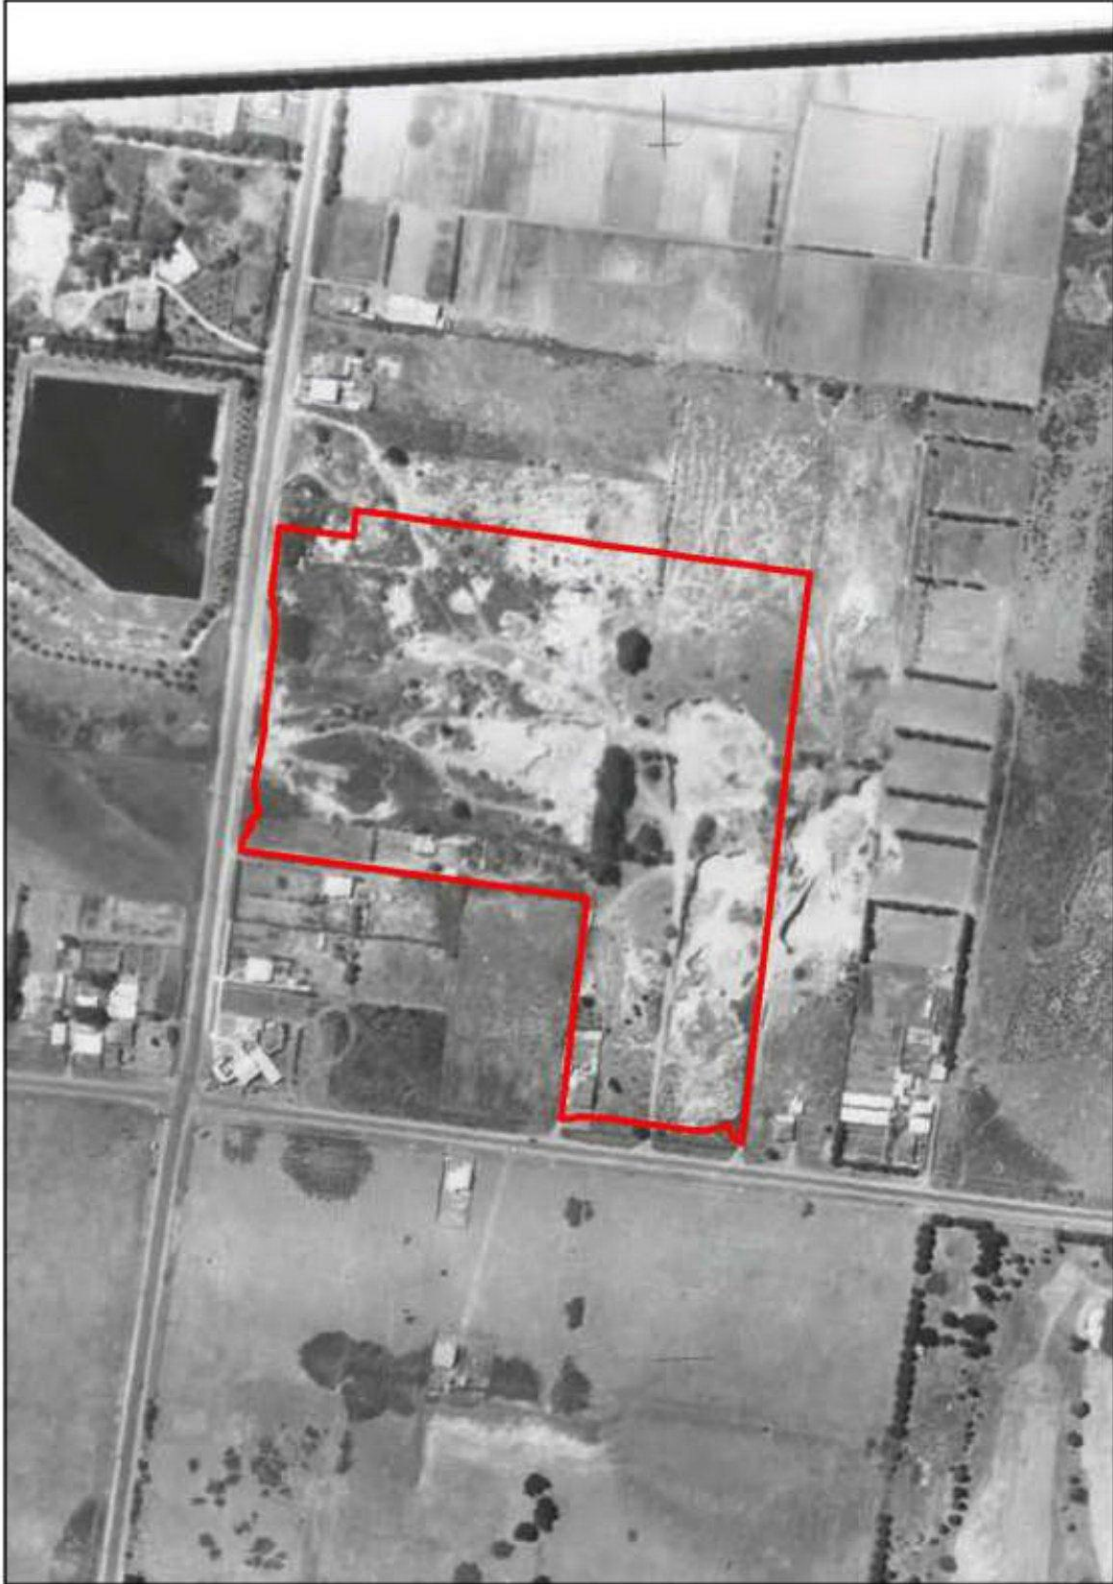
Figure 3: 1945 Aerial, activity area in red.

A 1945 aerial reveals the quarry has been expanded into the eastern half of the activity area, with the dwelling and sheds removed (Figure 3). The tree plantings down the centre of the activity area are still present. The quarry extends further east past the boundary of the activity area, and the surrounding land is still predominantly rural farmland.

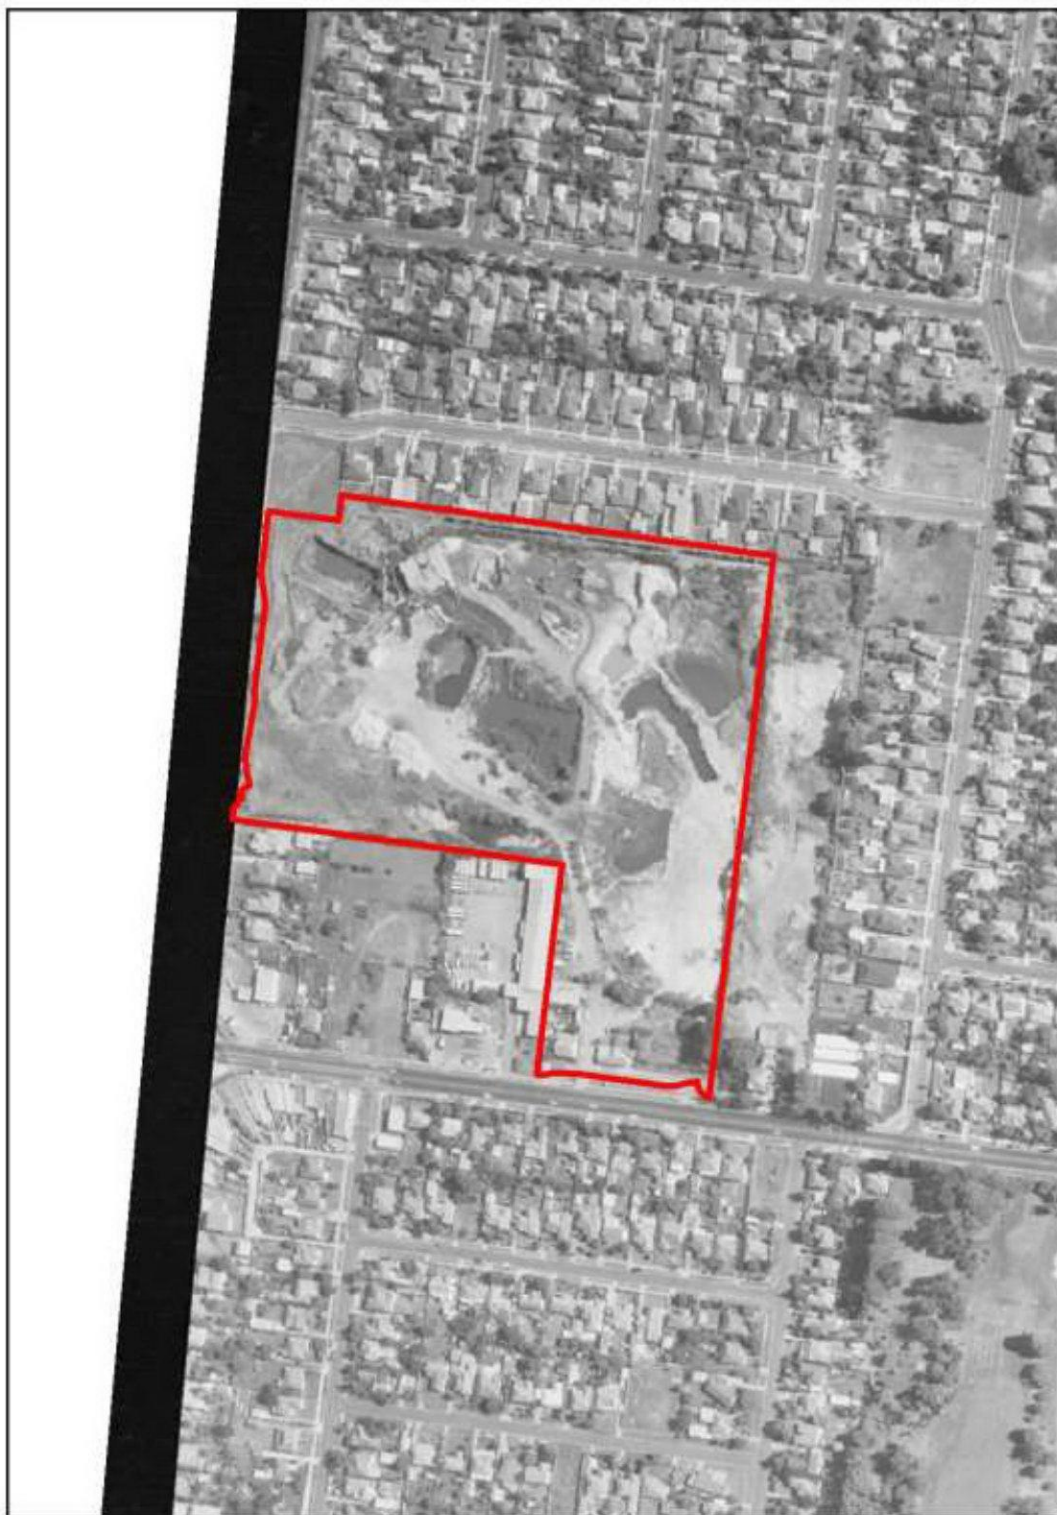
Figure 4: 1972 Aerial photograph, activity area in red.

By 1972 the quarry has expanded further throughout the activity area, with the row of tree plantings down the centre having been removed by this time (Figure 4). Buildings have been constructed along the southern boundary abutting Centre Road, and the cutting for the quarry can be seen along the northern boundary to be quite deep (Figure 4). The surrounding area has been extensively developed into residential neighbourhoods.

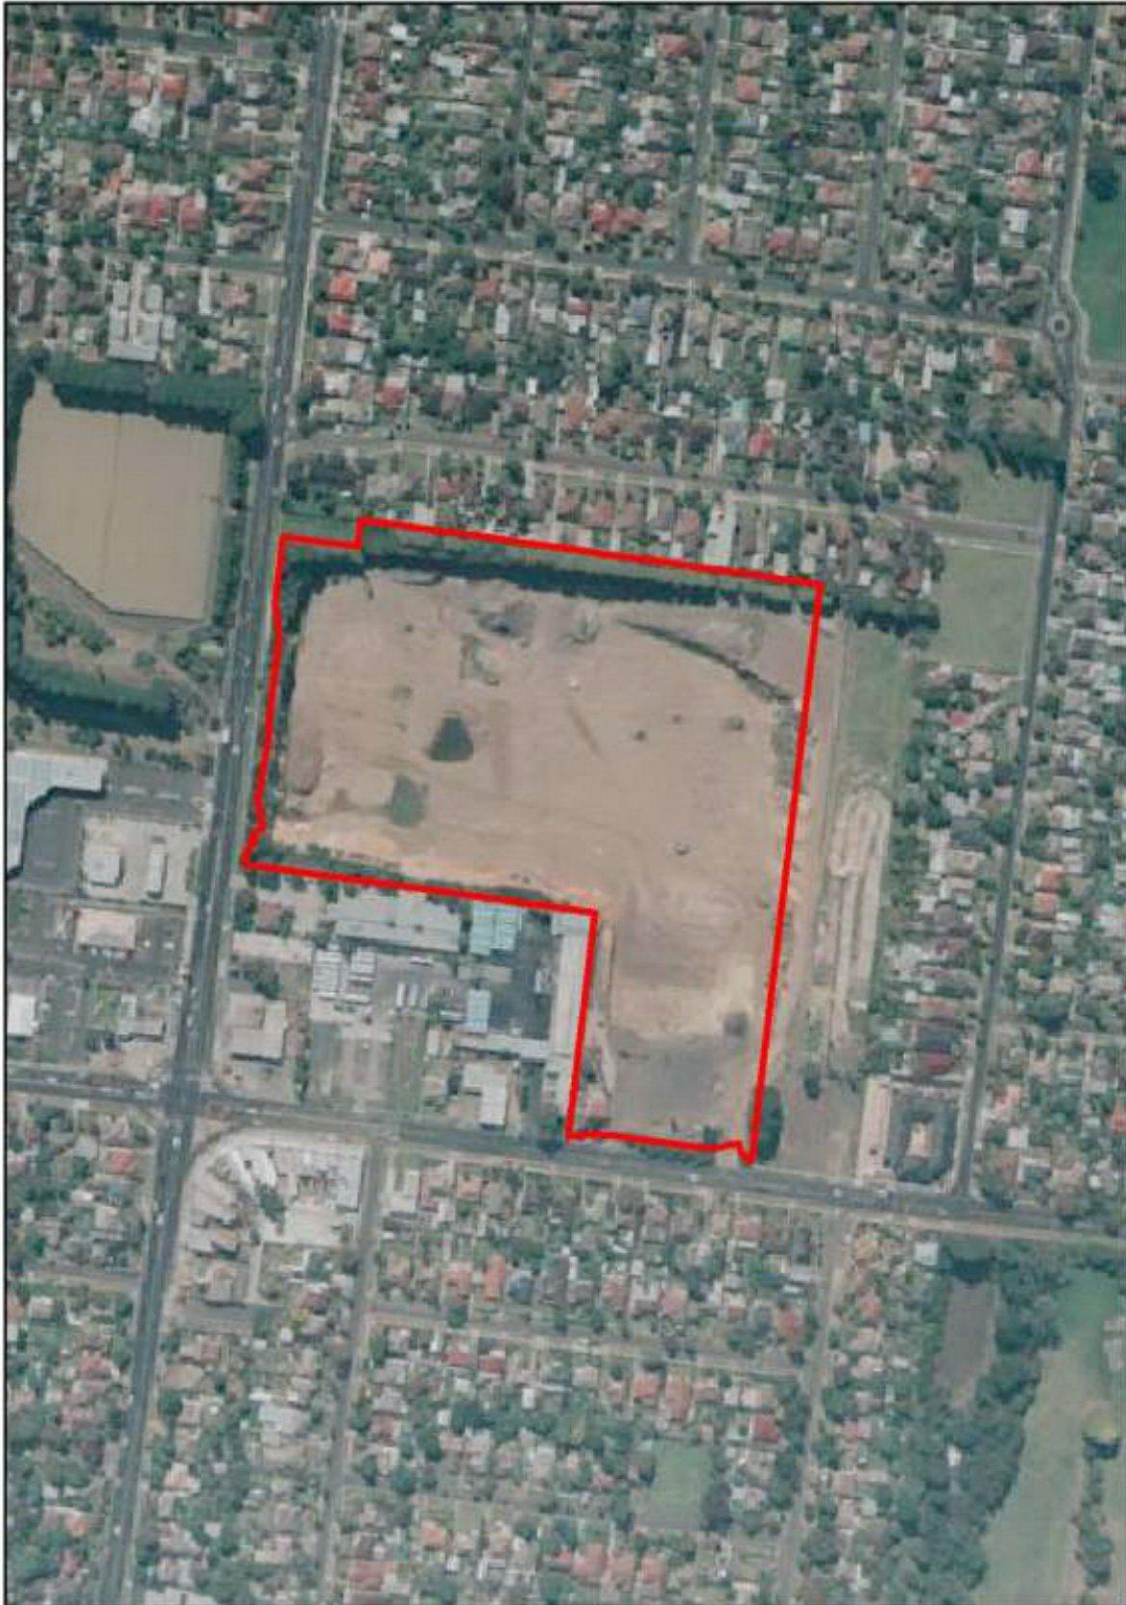
Figure 6: 1991 Aerial photograph, activity area in red.

A decade later in 1991, an aerial photograph reveals the quarry is in the process of being filled in, with all of the ground surface within the activity area having been levelled and the surface in the process of being scraped clear (Figure 6). Only one building remains in the southwest corner of the southern section abutting Centre Road.

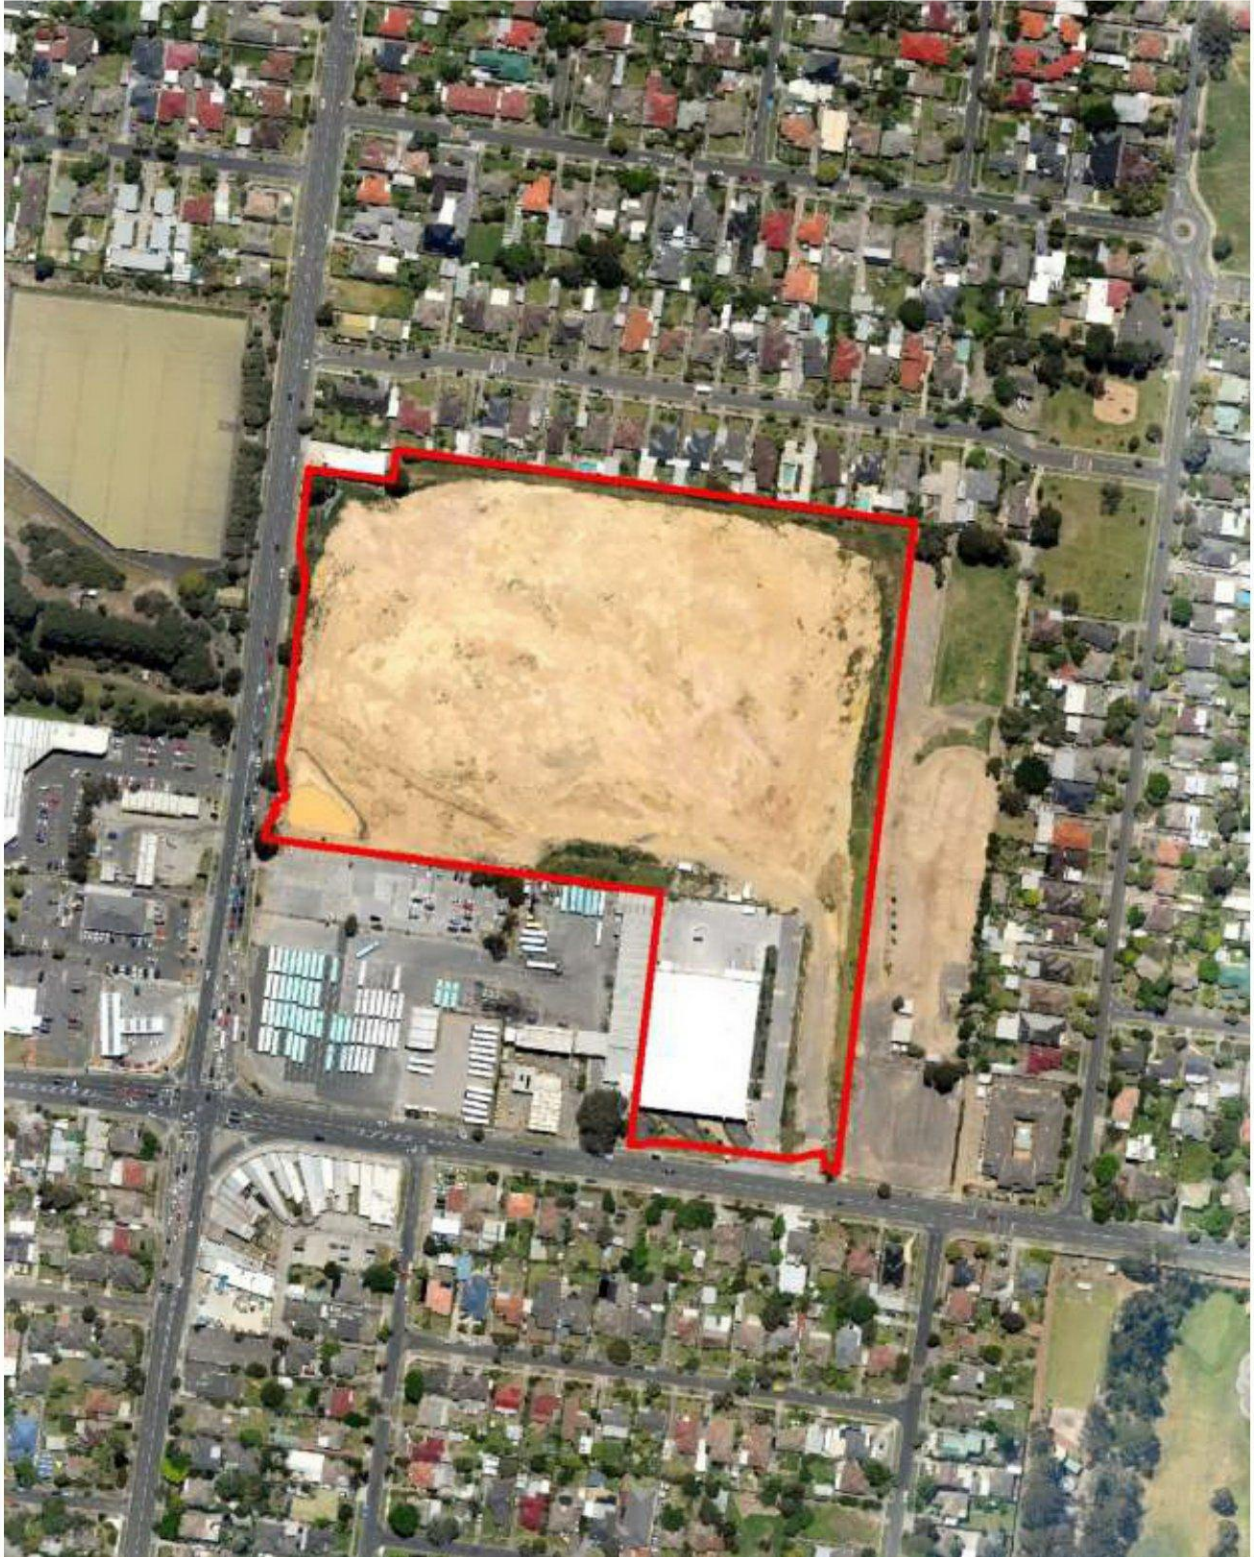
Figure 7: 2009 Aerial photograph, activity area in red.

By 2009 the northern part of the activity area remains vacant, clear land (Figure 7). The building in the southwest corner of the southern section has been removed, and a large building has been constructed in this section; operating as a Harvey Norman retail shop (Figure 7). A large portion of the land to the southwest of the activity area has been turned into a large hardstand area, likely to service the new building within the activity area.

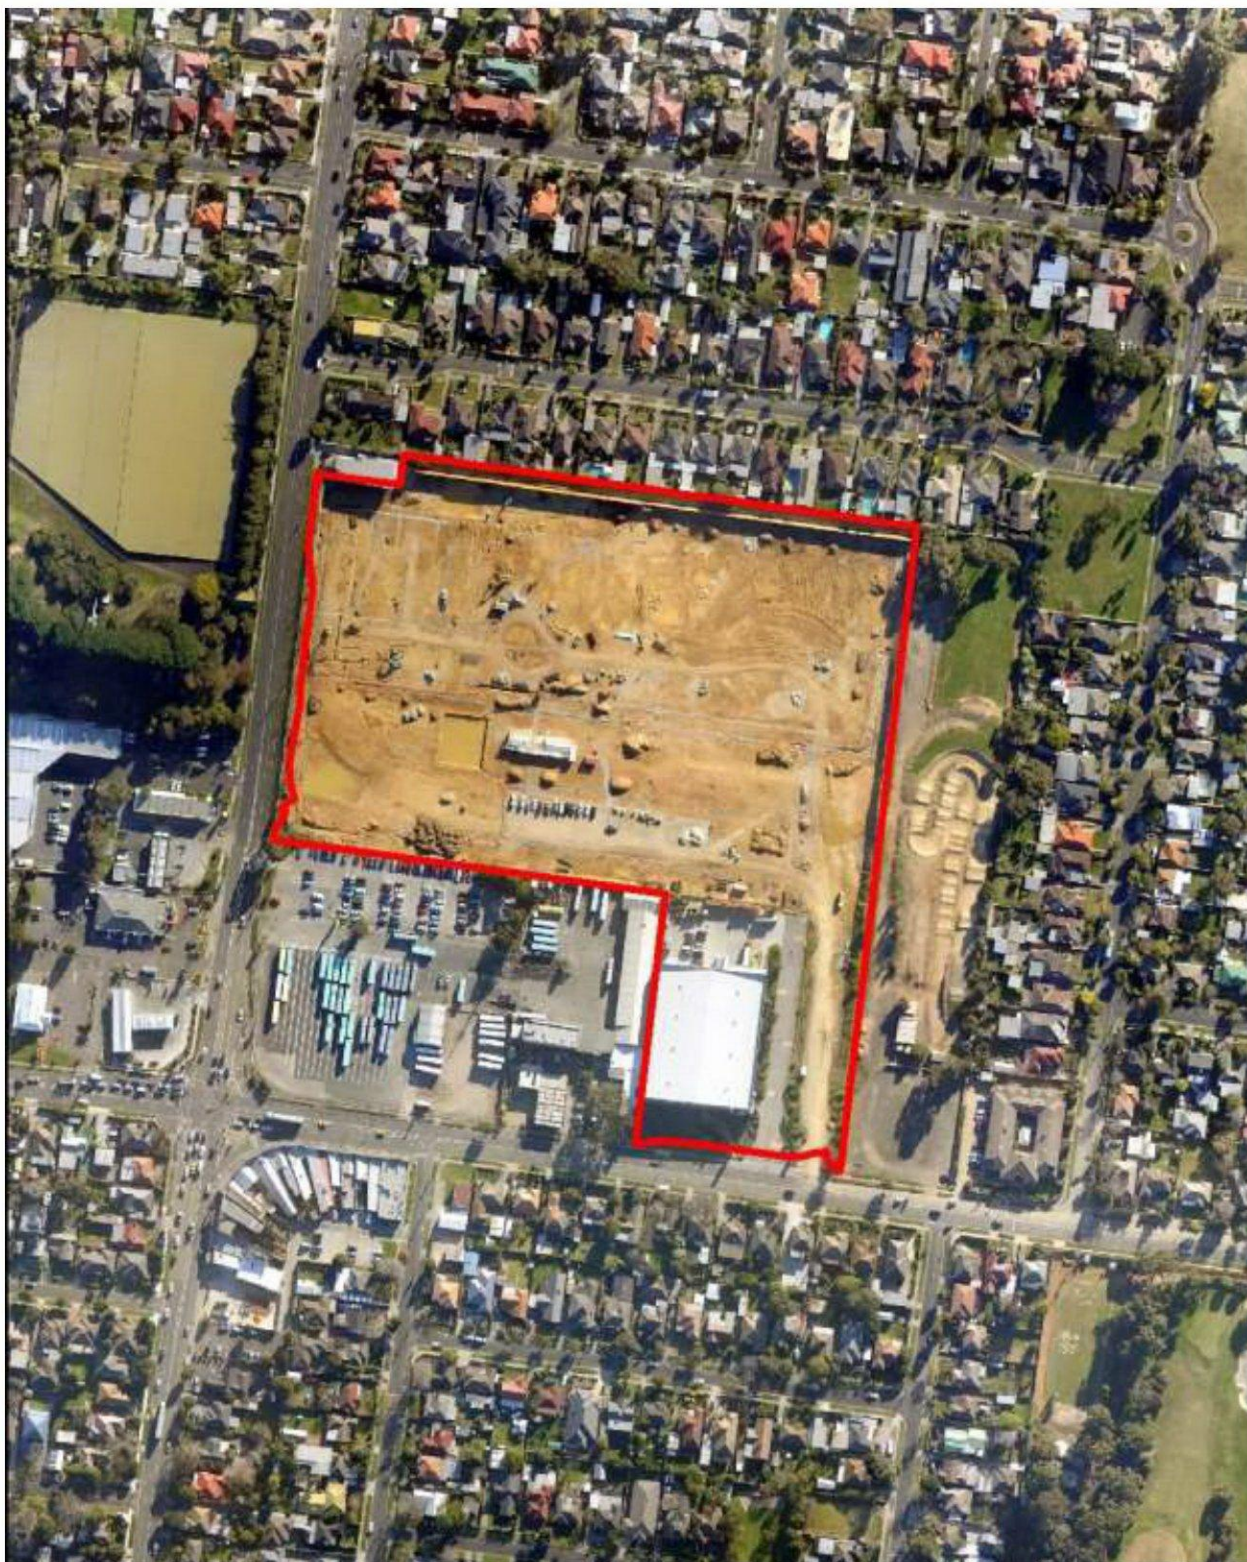
Figure 8: 2011 Aerial photograph, activity area in red.

In 2011 aerial photography clearly shows the northern section of the activity area is in the process of being developed, with all of the ground surfaces being scraped with machinery, stockpiles of dirt and construction buildings onsite, and footings being excavated (Figure 8).

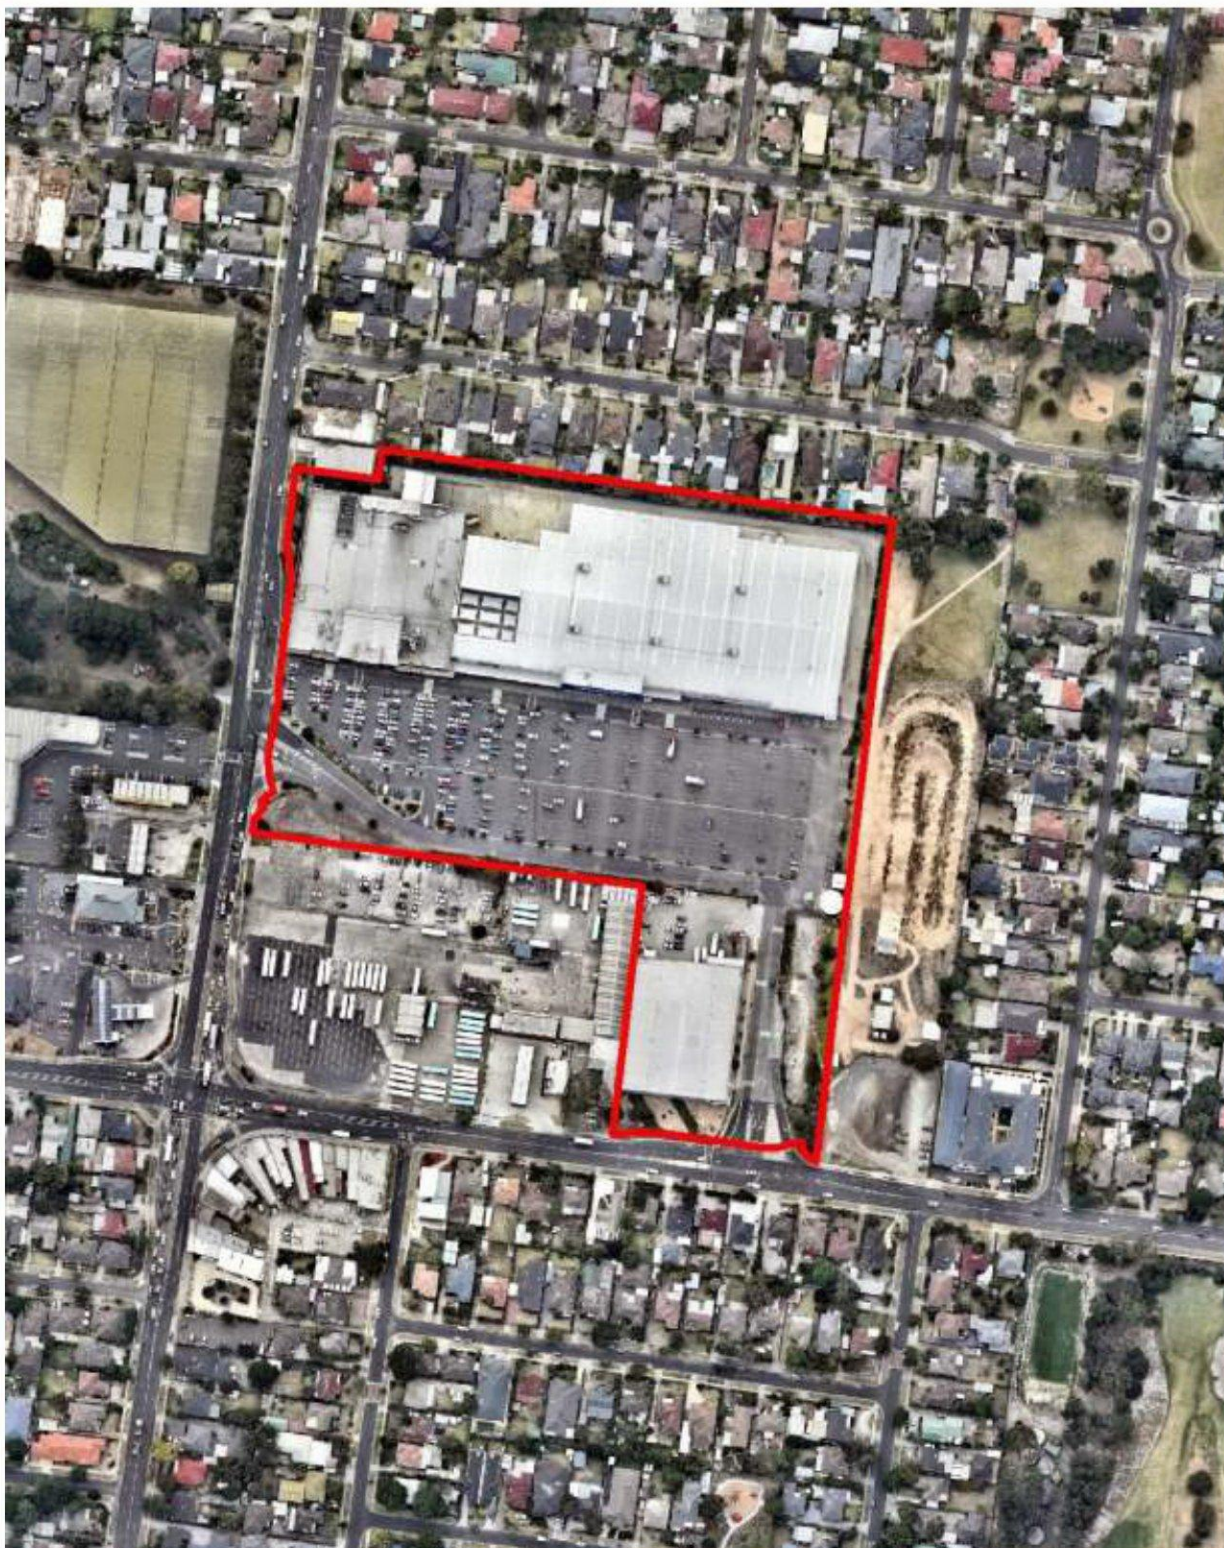
Figure 9: 2018 Aerial photograph, activity area in red.

A 2018 aerial image reveals all of the northern half of the activity area has now been developed with large buildings and hardstand carparking areas throughout, and large access roadway leading off Centre Road into the complex on the south (Figure 9). The current use of the activity area is a large shopping complex comprising a Woolworths, Bunnings, Harvey Norman and shopping mall with associated carparking and landscaping.
