Environmental Site Assessment- Preliminary Site
Investigation (Site History Review) and Detailed Site
Investigation (Soil Investigation)

570 Neerim Road,
Hughesdale, Victoria

4 November 2016

51810 - 105922 Rev 1 (FINAL)

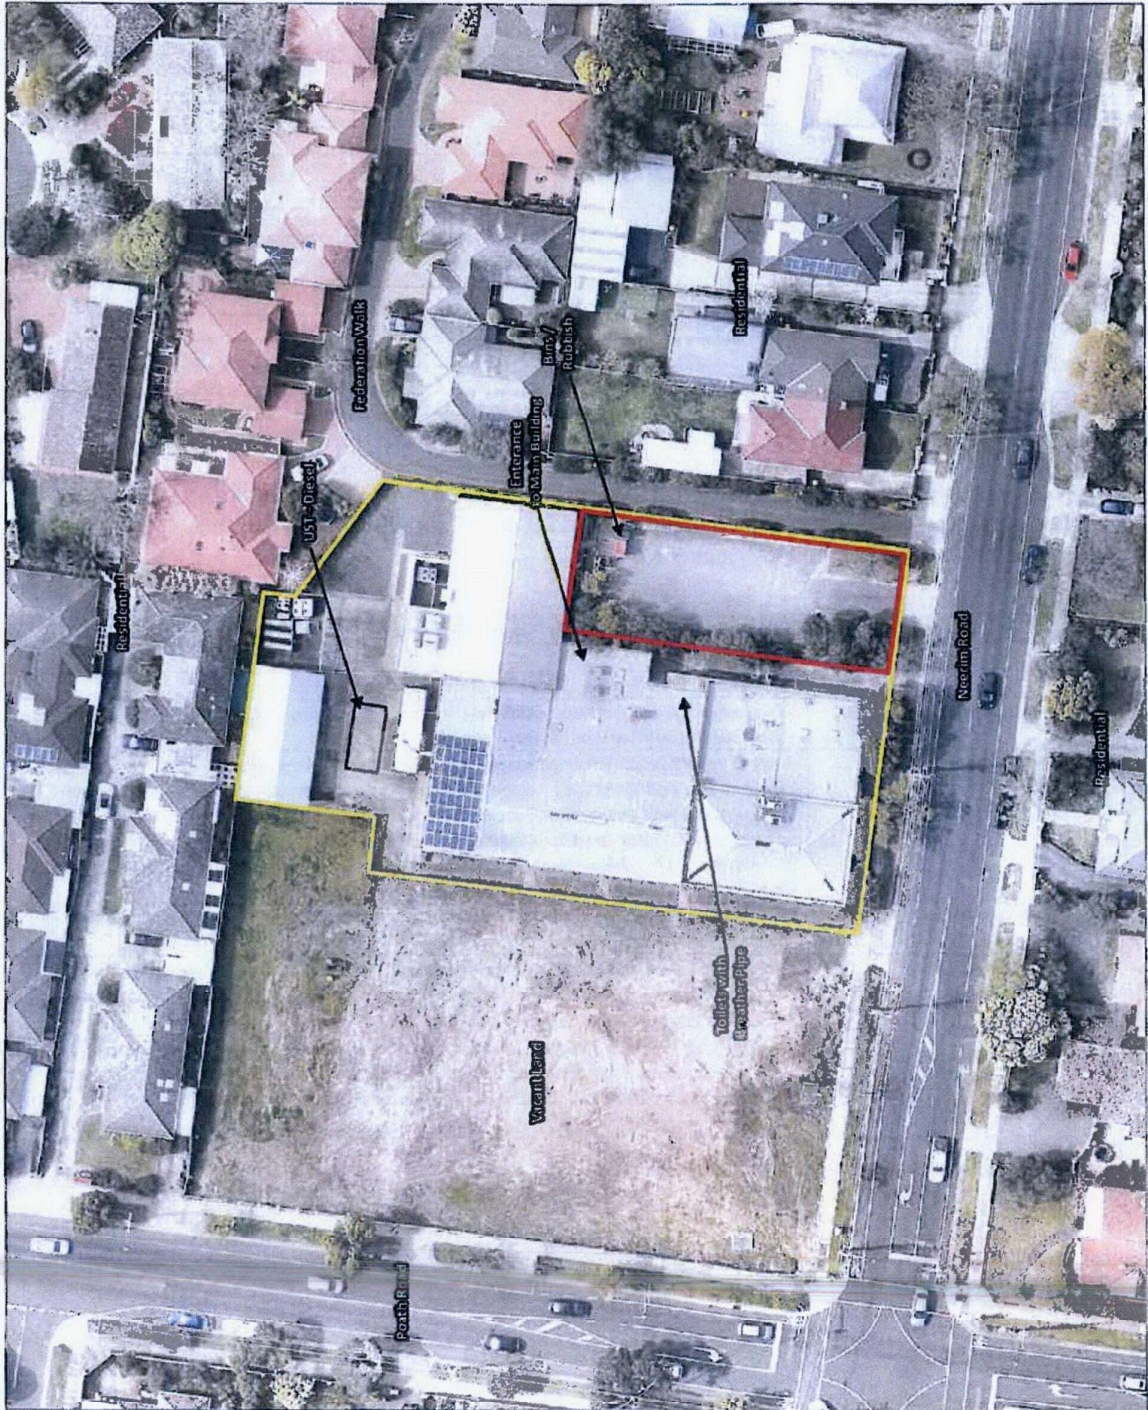
FIGURE 2

The current site layout is shown in Figure 2.

SITE LAYOUT

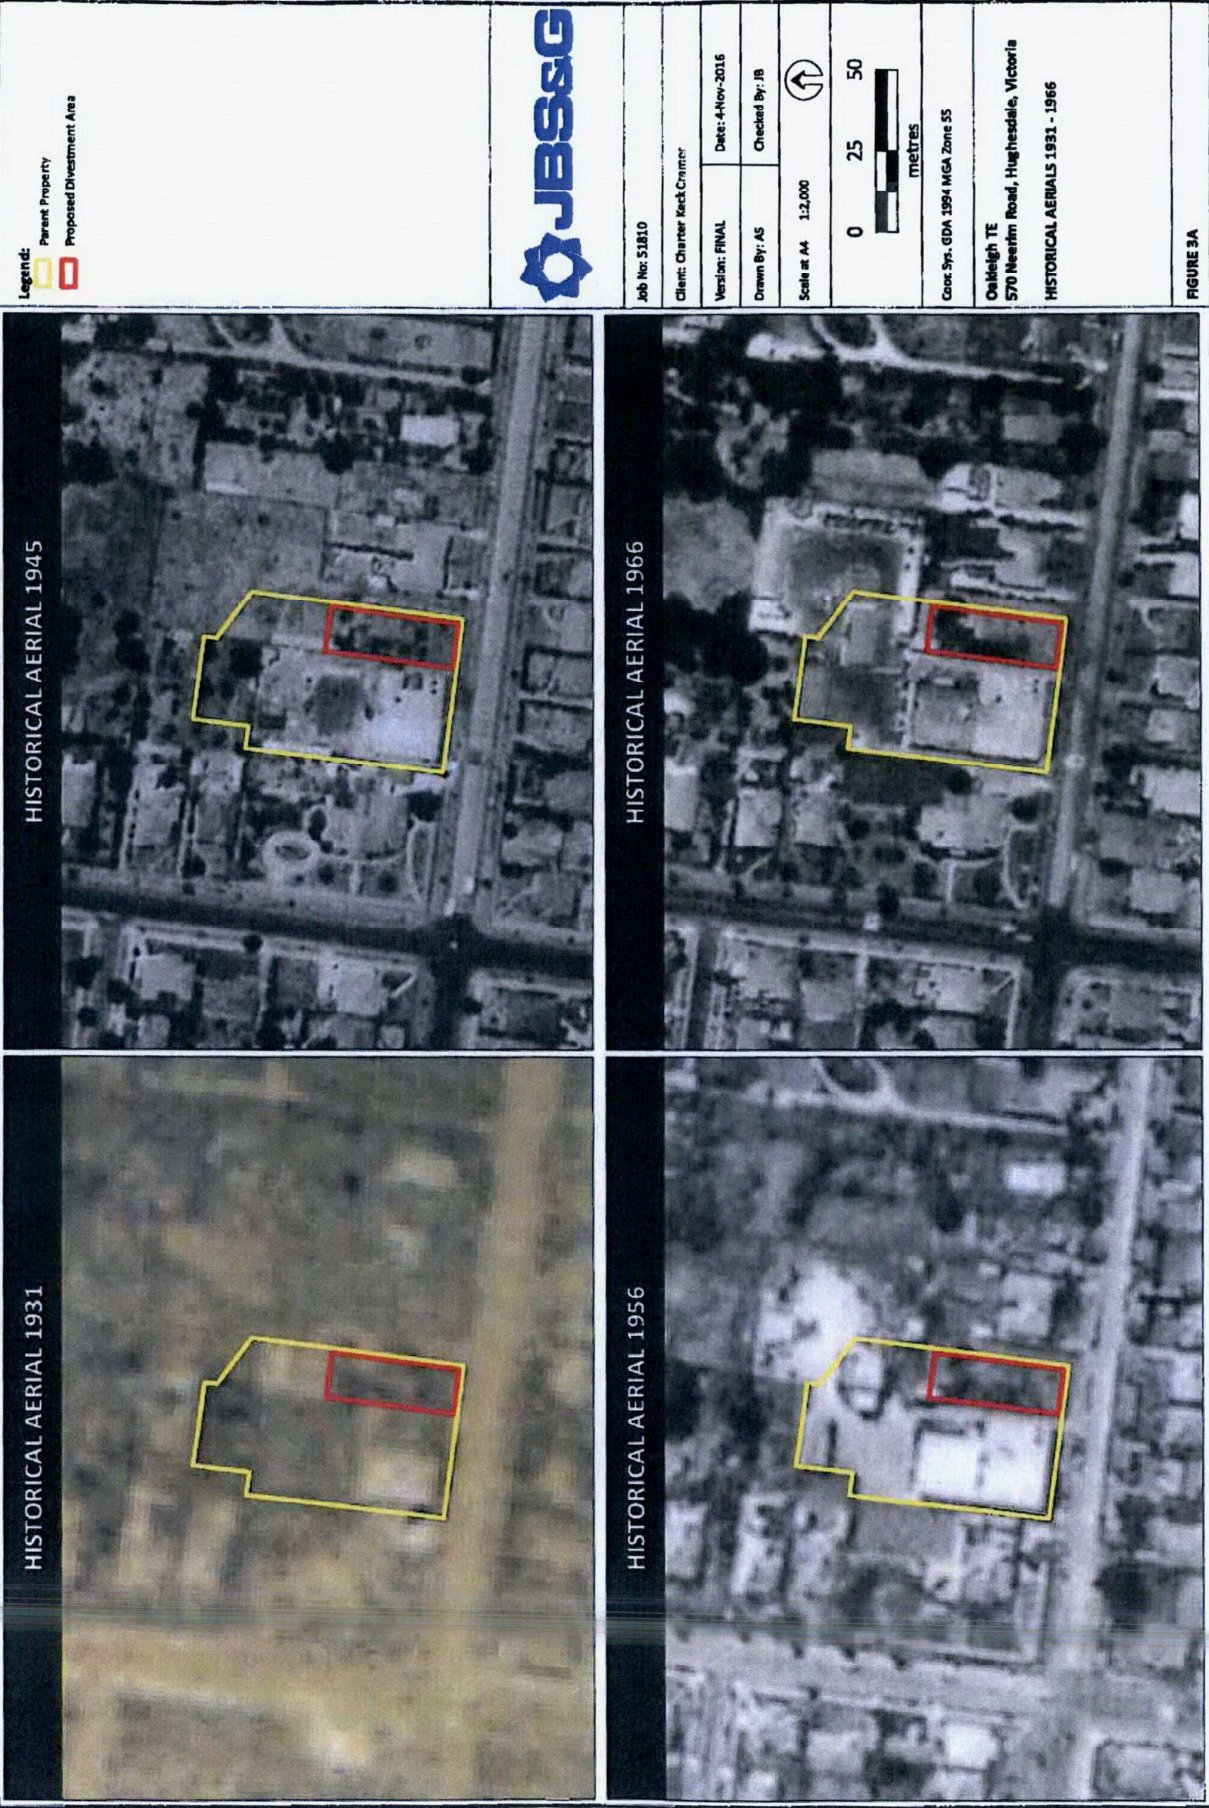
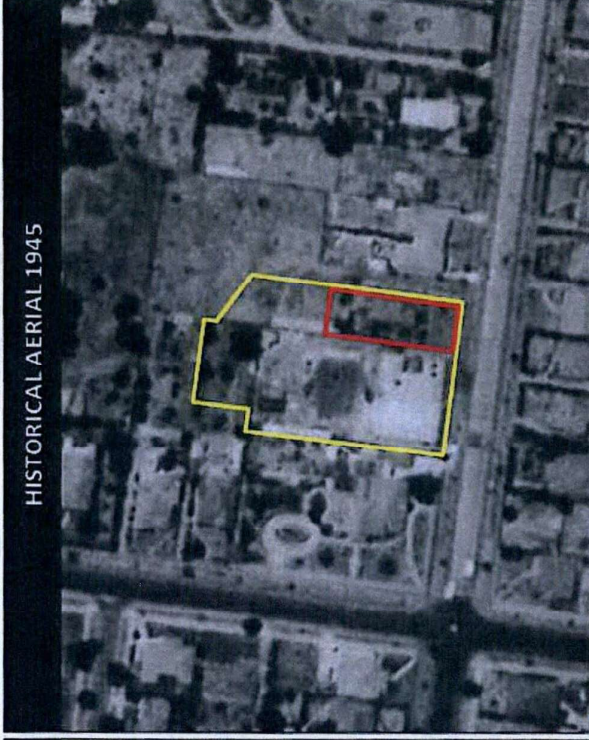
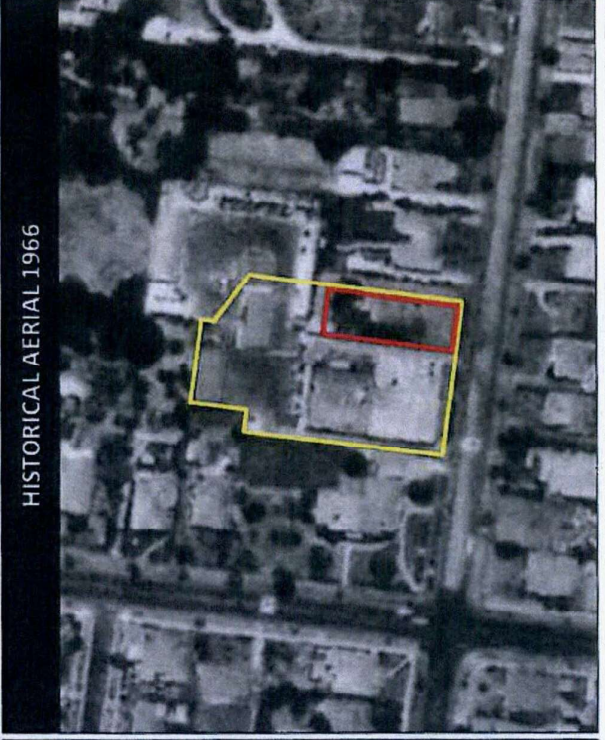
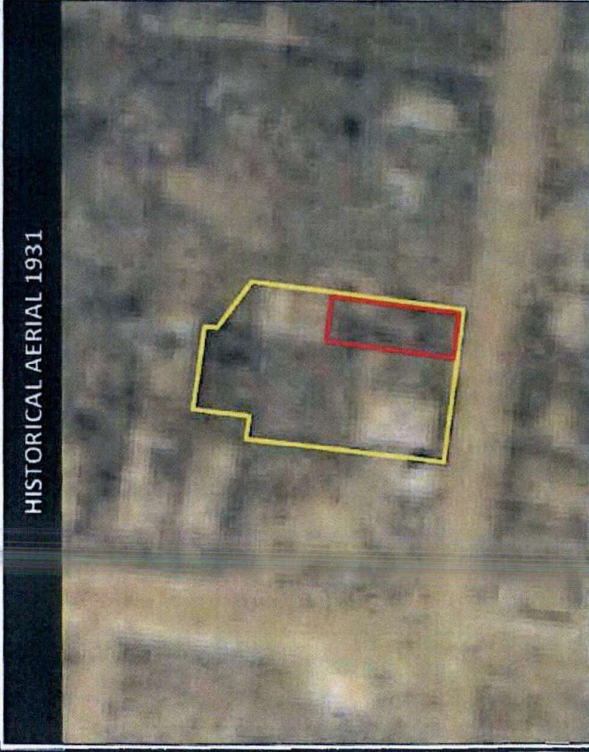
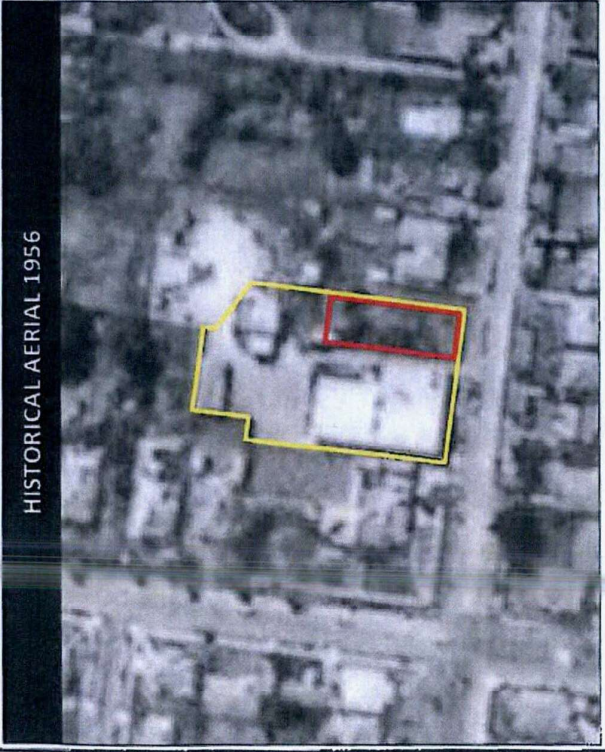
Table 8 presents a summary of the review of historical aerial photographs relating to the site. Copies of the aerial photographs are presented in Figure 3A and Figure 3B, with the approximate site boundaries shown for reference.

Date	Comments
1931	<ul style="list-style-type: none"> The quality of the photograph is poor, however, the following general statements can be made: <ul style="list-style-type: none"> The site appears to be clear and potentially agricultural land. A building appears to exist to the south west of the site. Neerim and Poath Roads have both been constructed.
1945	<ul style="list-style-type: none"> The site appears to have been covered in concrete, apart from some vegetation (likely garden beds) located in the north and the south-east corner. The building still remains in the south-west. There has been residential development around all boundaries of the site.
1956	<ul style="list-style-type: none"> The quality of the photograph is poor, however, the following general statements can be made: <ul style="list-style-type: none"> A building has been constructed in the north-west corner. A shed has also been constructed in the north-west corner. The south-west building appears to have been extended and now takes up approximately 1/3 of the site's area. The site's area appears to have increased since the aerial photo taken in 1945, with more concrete extending out to the north-east corner.

1966	<ul style="list-style-type: none"> The extended site boundary to the north-east appears to have had some further development, with construction of buildings on the boundary. The building on site does not appear to have undergone any further developments. Surrounding area continues to develop into residential properties.
1975	<ul style="list-style-type: none"> The quality of the photograph is poor, however, the following general statements can be made: <ul style="list-style-type: none"> The building in the south-west has been extended again and now takes up approximately half of the site. The site boundary extension in the north-east corner appears to have increased again including more concreted area.

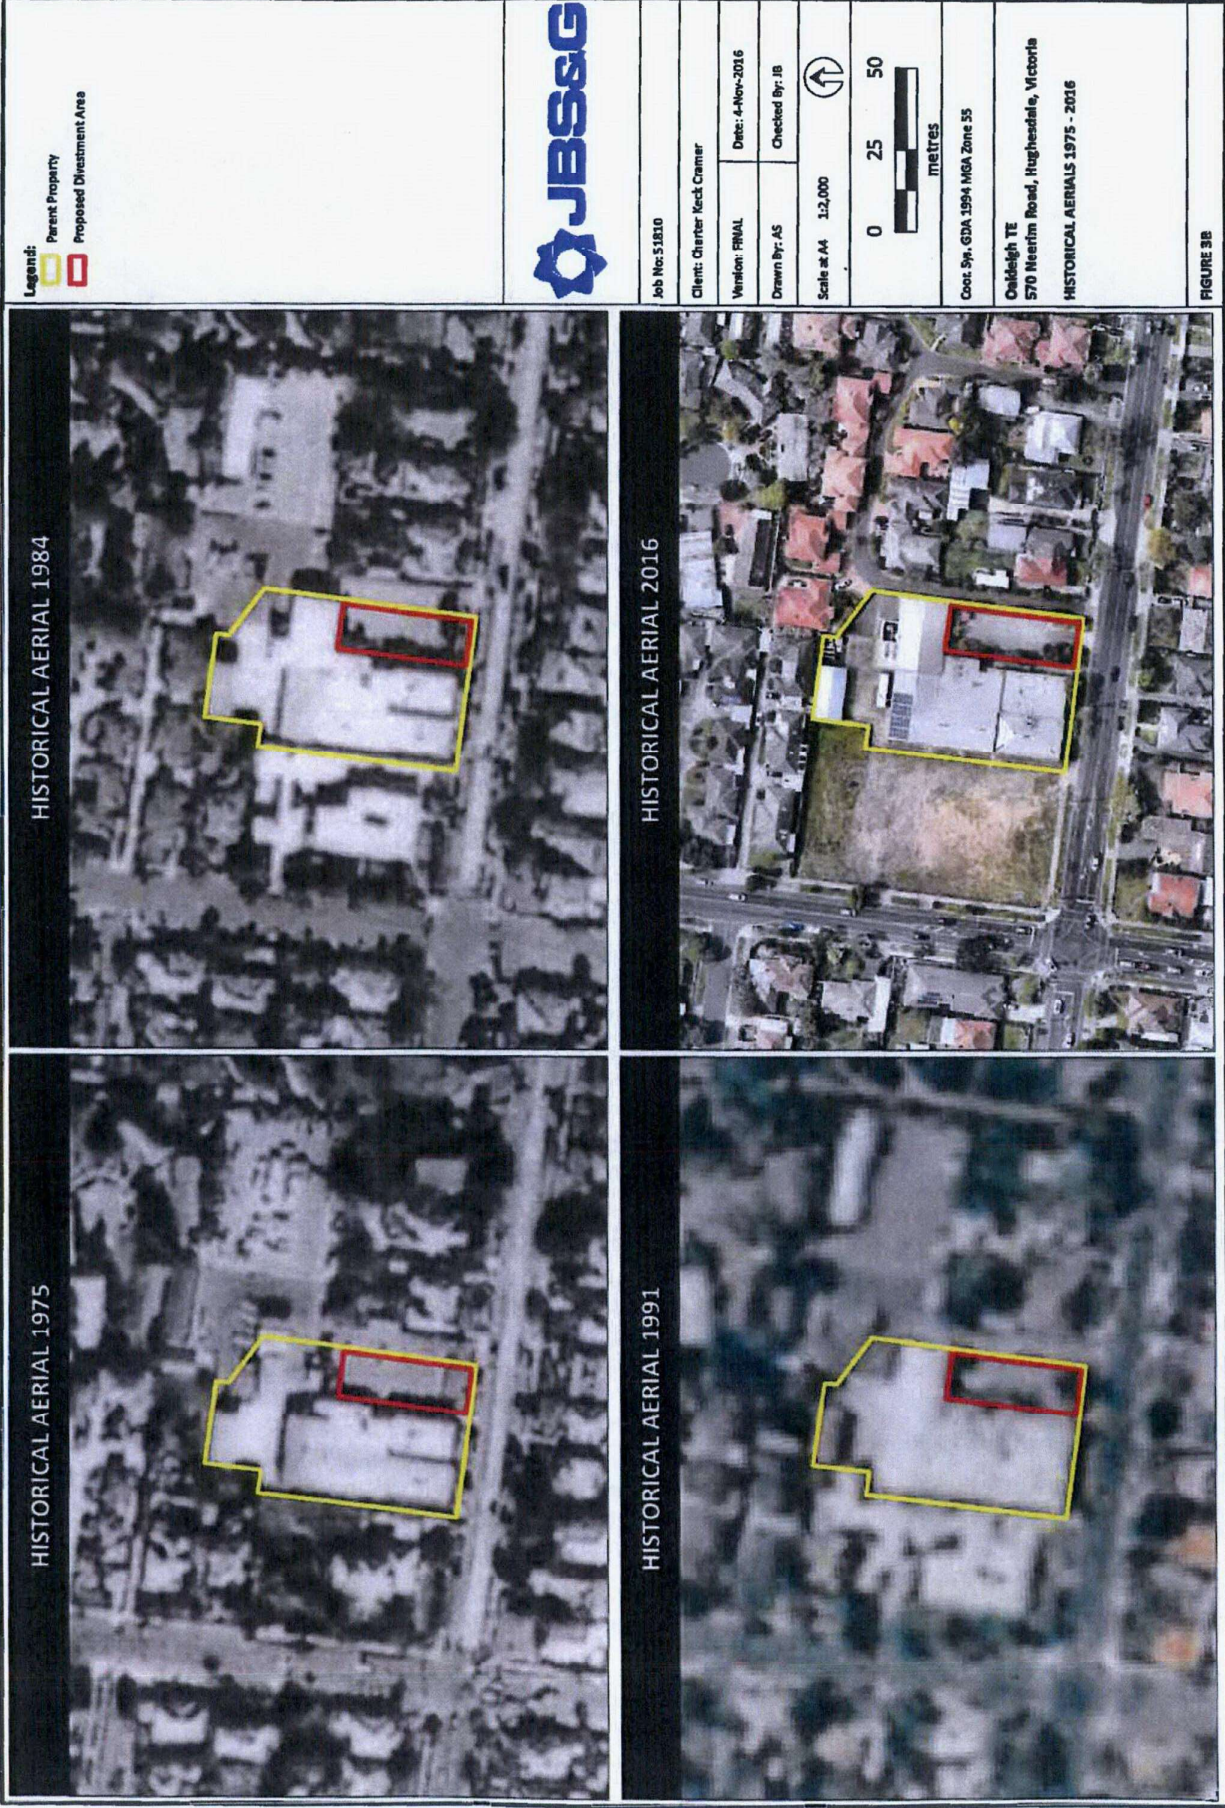
FIGURE B8

Date	Comments
1984	<p>The quality of the photograph is poor, however, the following general statements can be made:</p> <ul style="list-style-type: none"> • The footprint of the building occupying the subject site is broadly consistent with the 1975 aerial photograph. • Another large building has been constructed on the western neighbouring property.
1991	<p>The quality of the photograph is poor, however, the following general statements can be made:</p> <ul style="list-style-type: none"> • The developed extension of the north-eastern corner has been cleared. • The main building still exists and takes up the majority of the site. • The large building in the western neighbouring property still remains.
2016	<ul style="list-style-type: none"> • The large building on site appears to have not undergone any further developments. • The neighbouring building on the western building has been demolished since the 1991 aerial photograph was taken. • The cleared area of the site extension has now been redeveloped into residential properties.

Job No: S1810	
Client: Charter Keck Cramer	
Version: FINAL	Date: 4-Nov-2016
Drawn By: AS	Checked By: IB
Scale at A4: 1:2,000	
0 25 50	
METRES	
Coord. Sys: GDA 1994 MGA Zone 55	
Oakleigh TE 570 Neerim Road, Hughesdale, Victoria	
HISTORICAL AERIALS 1975 - 2016

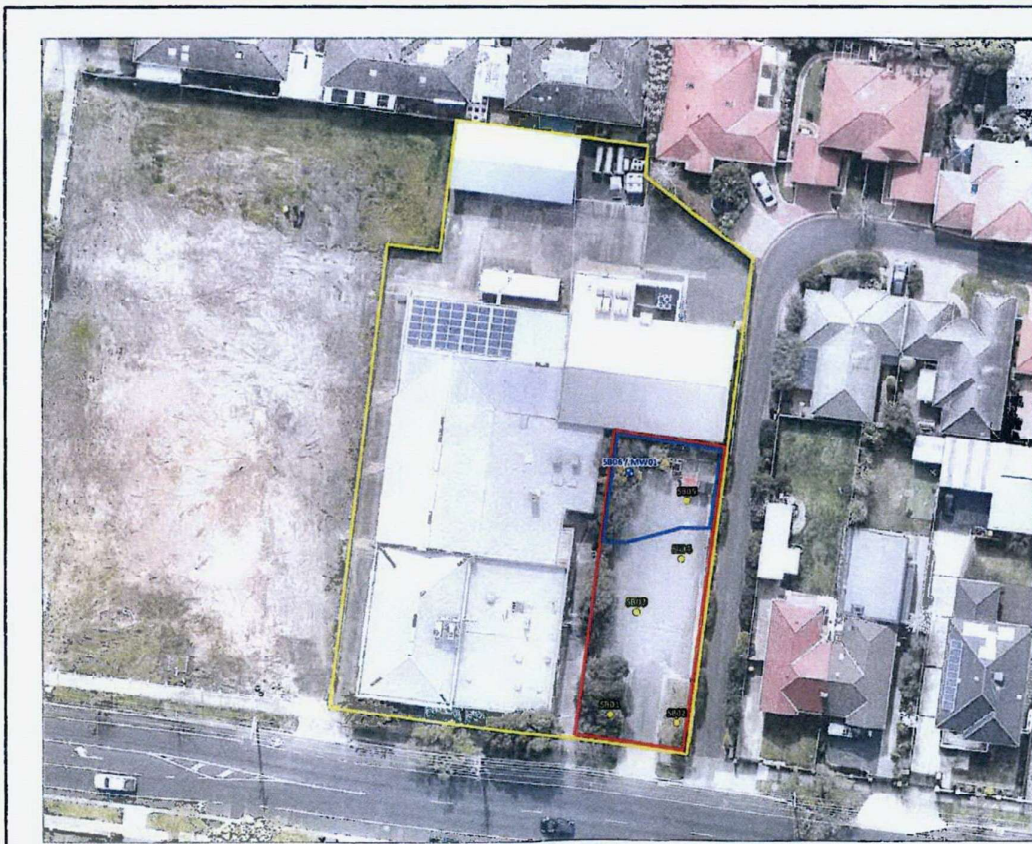
Elevated concentrations of lead and benzo(a)pyrene were reported to exceed the adopted human health criteria for low density residential use at a number of locations in samples collected from fill material. It is noted that all samples that exceeded the adopted ecological and human health criteria were collected from the historically placed fill materials.

- Legend:**
- Parcel Property
 - Proposed Divestment Area
 - Groundwater Monitoring Well
 - Soil Borehole
 - Potential Area of Lead Impacts

Lead and benzo(a)pyrene were identified in soil at concentrations exceeding the Health Investigation Levels (HIL) for low density residential use. The elevated concentrations were restricted to historical imported fill materials within some portions of the site. Depending on the proposed use of the site, these soils may need to be remediated or managed appropriately.
