# Arboricultural Assessment

## 35 - 39 Regent Street, Mount Waverley

Prepared for: Japara HealthCare

7 July 2016

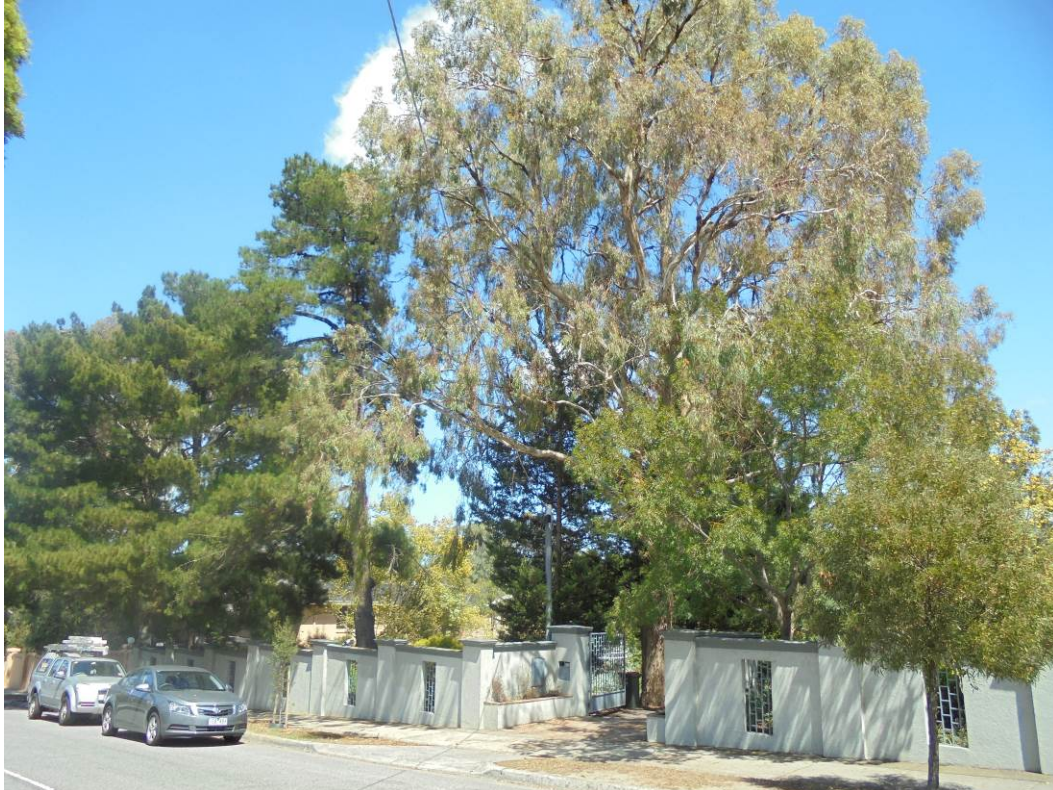
*Figure 3: Shows the street frontage at 35 – 37 Regent Street, Mount Waverley. The mature trees along the front setback made a valuable contribution to the streetscape of Regent Street.*

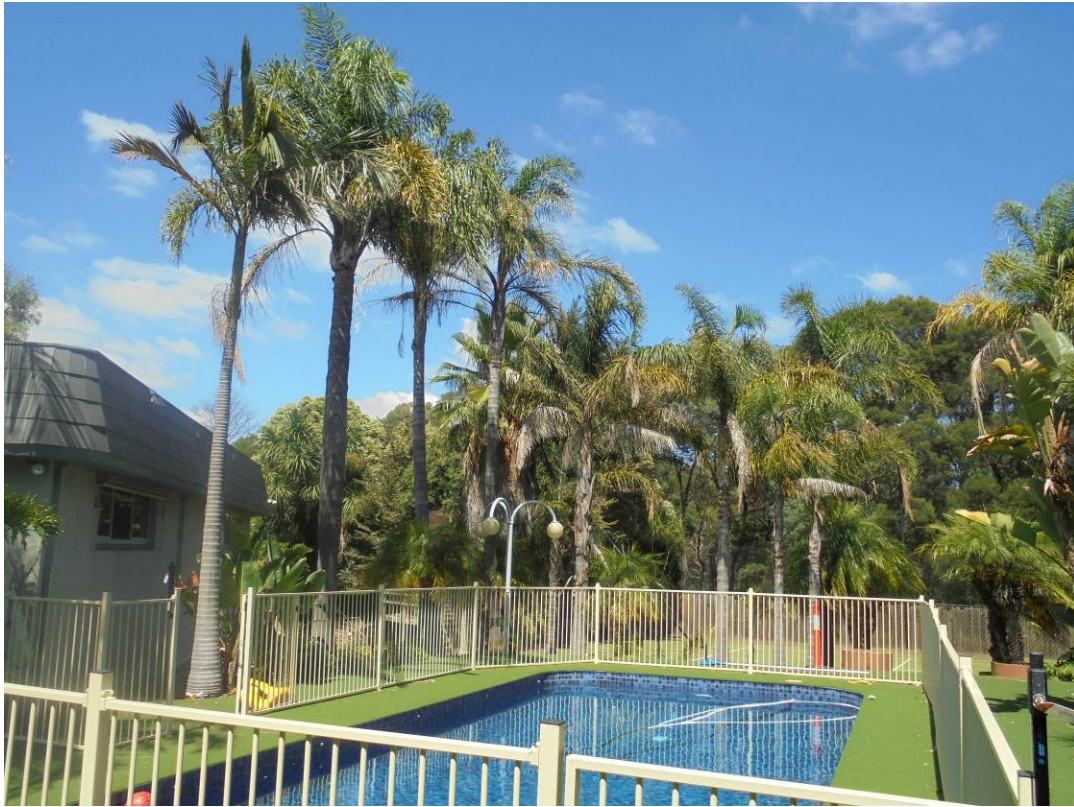
*Figure 7: Shows the Queen Palms (Syagrus romanzoffiana) of tree group 1 surrounding the pool area.*

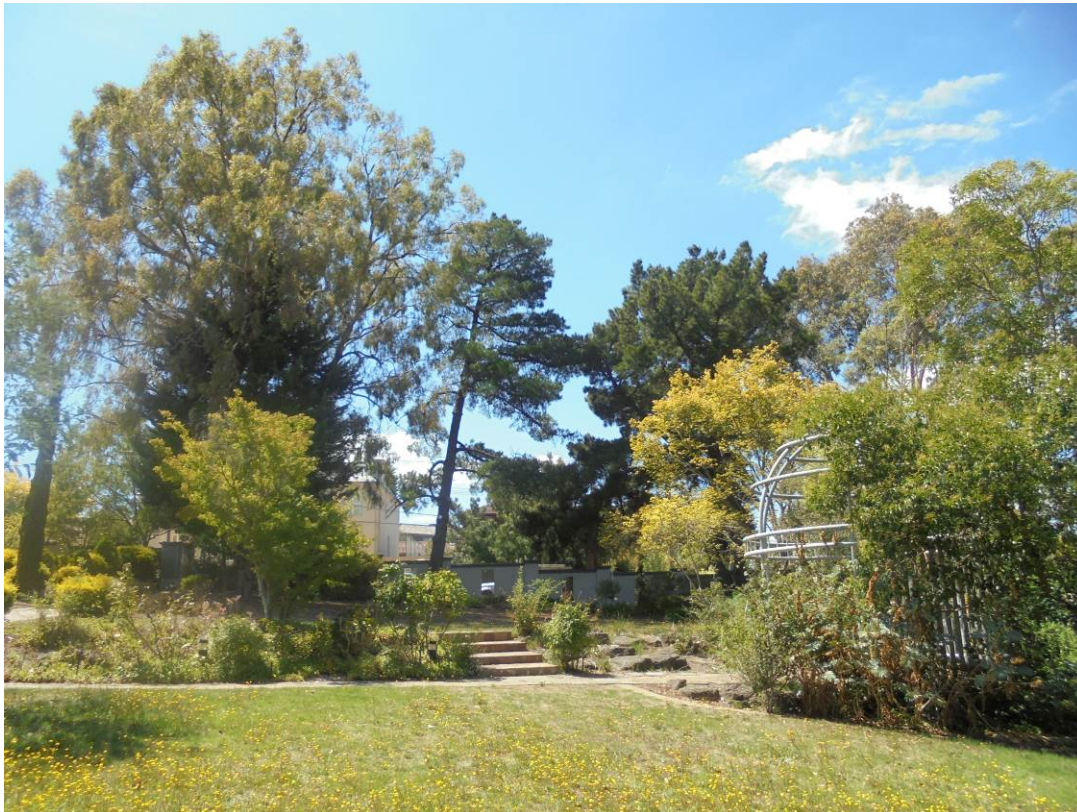
*Figure 8: View to the east showing the existing site conditions.*

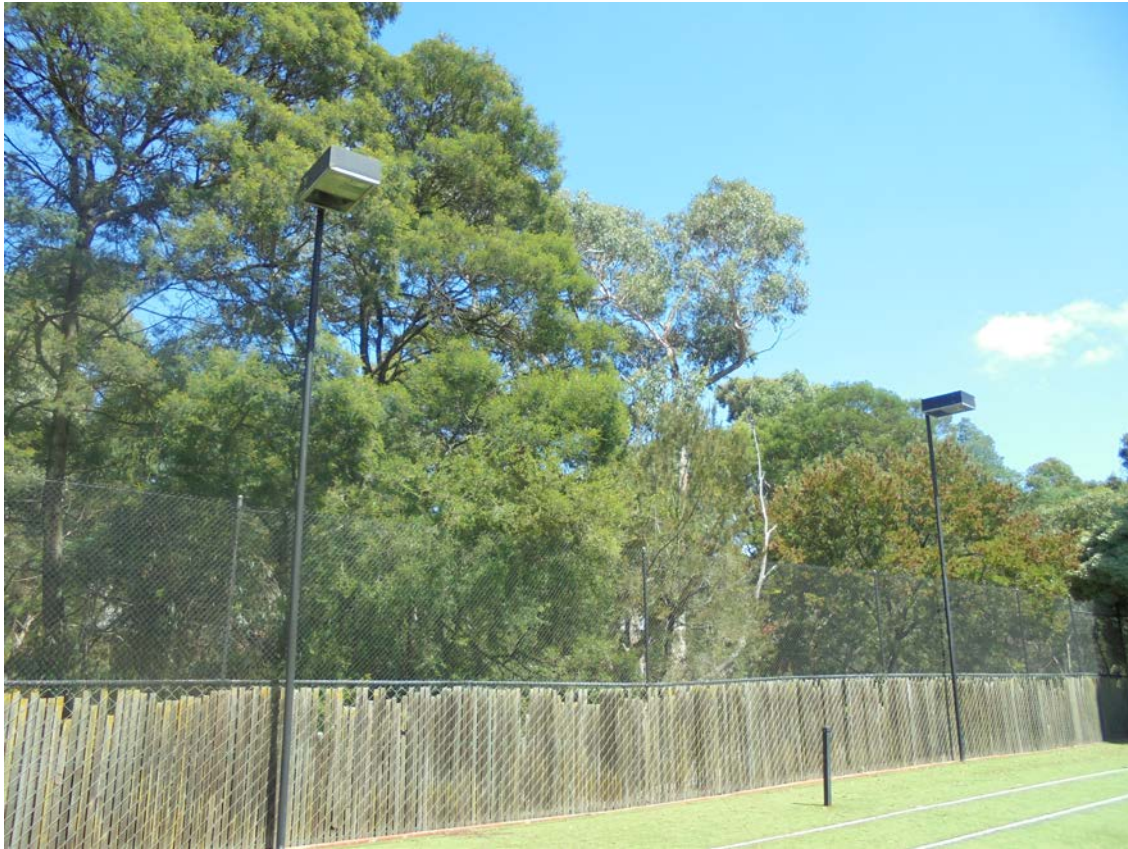
*Figure 9: Shows the adjacent trees in Valley Creek Reserve which are well set back from the subject site at 35 – 37 Regent Street, Mount Waverley.*

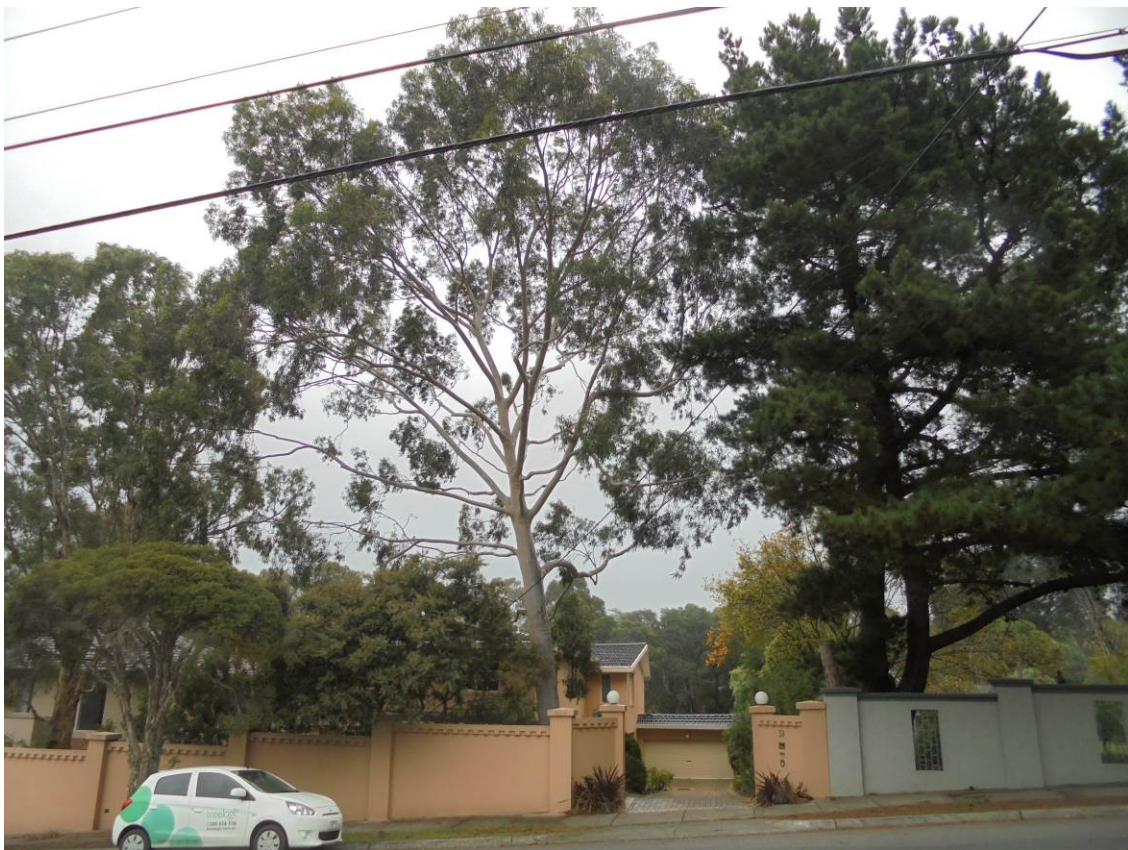
*Figure 10: Shows the street frontage at 39 Regent Street, Mount Waverley. The mature trees along the front setback made a valuable contribution to the streetscape of Regent Street.*

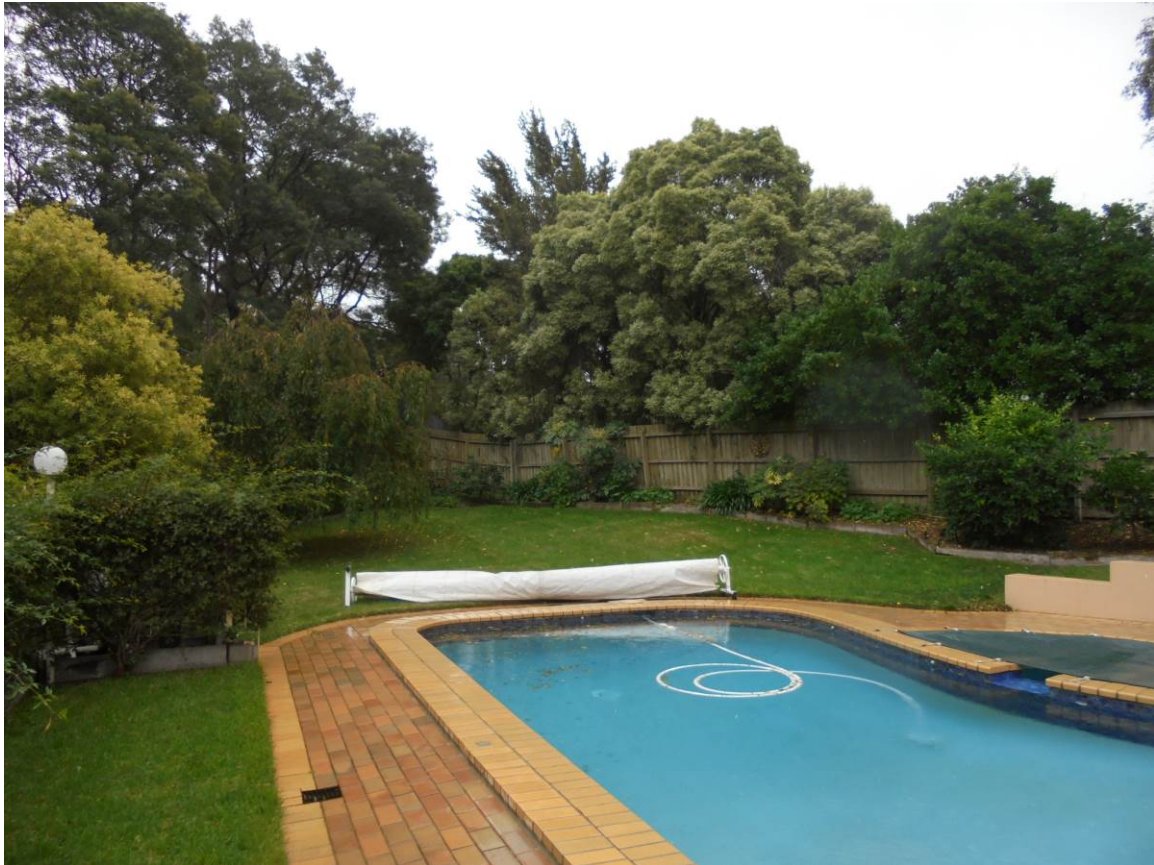
*Figure 13: Shows the existing conditions within the rear setback. Trees 42 –45 located within Valley Reserve and trees 48 and 49 can be seen to the left of the image.*

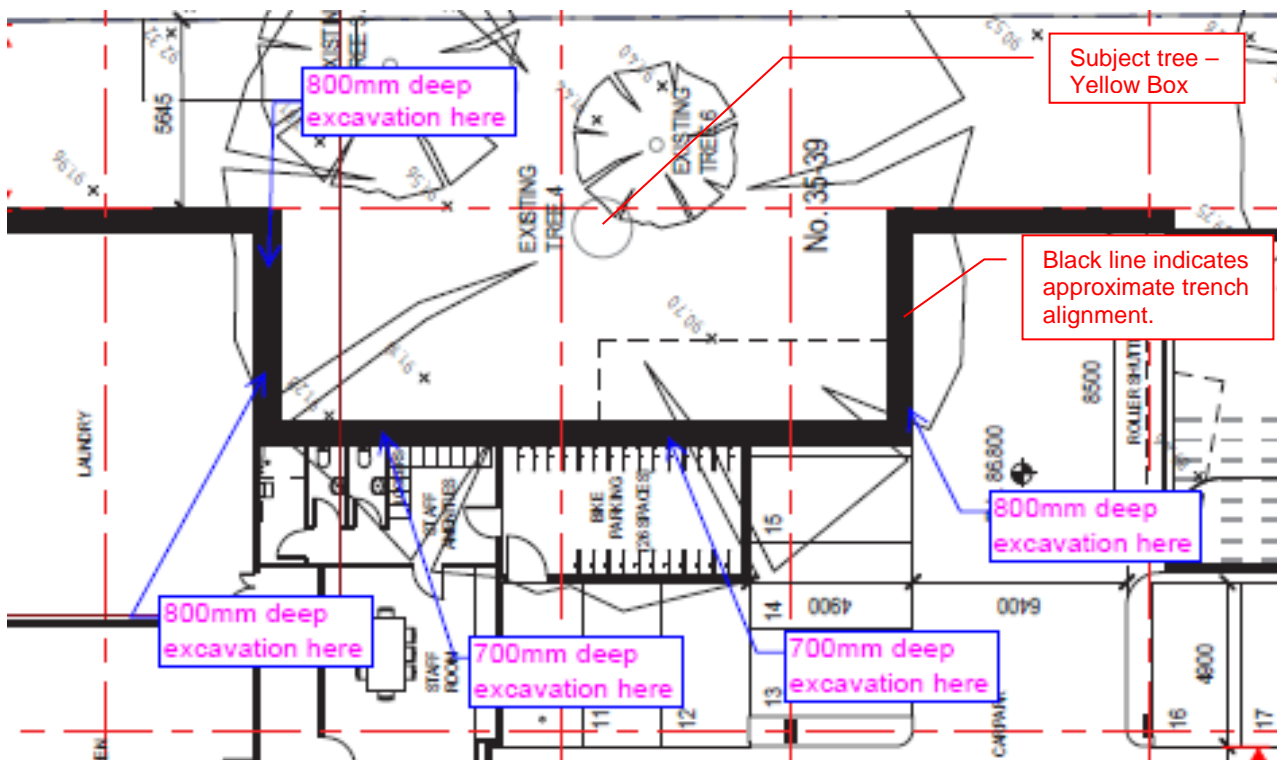
The investigation trench followed a U-shaped alignment as set out in Figure 1 indicated by the solid black line. The trench alignment was 5m to the west, 8m to the south and 9m to the north of the Yellow Box. The depth of the trench was at 450mm with several explorations to 700 - 800mm in depth at intervals along the trench. These deeper excavations typically were of 1.5 to 2m in length. Part of the existing driveway was removed to investigate the heaving as a root was suspected of being the cause.

**Figure 1:** Shows the location of the subject tree and the approximate alignment of the root investigation at 35 – 37 Regent Street, Mount Waverley.

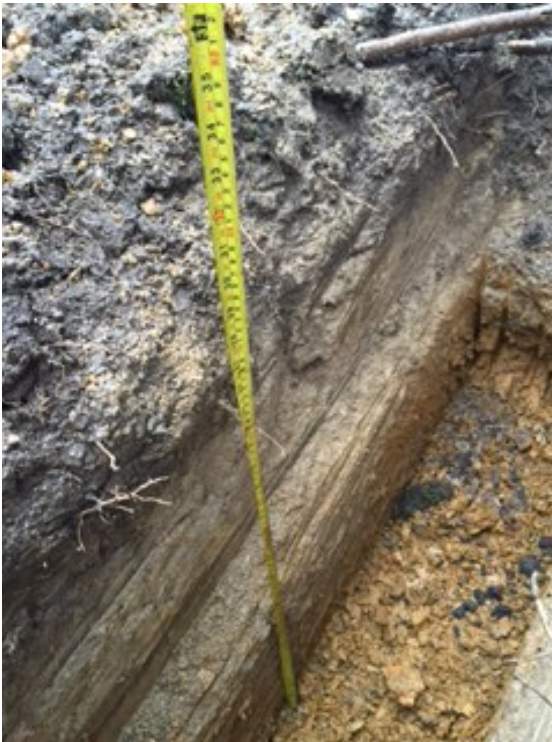
**Above Left:** Shows one of the deep excavations carried out on site with crumbly clay soil in the bottom of the trench.

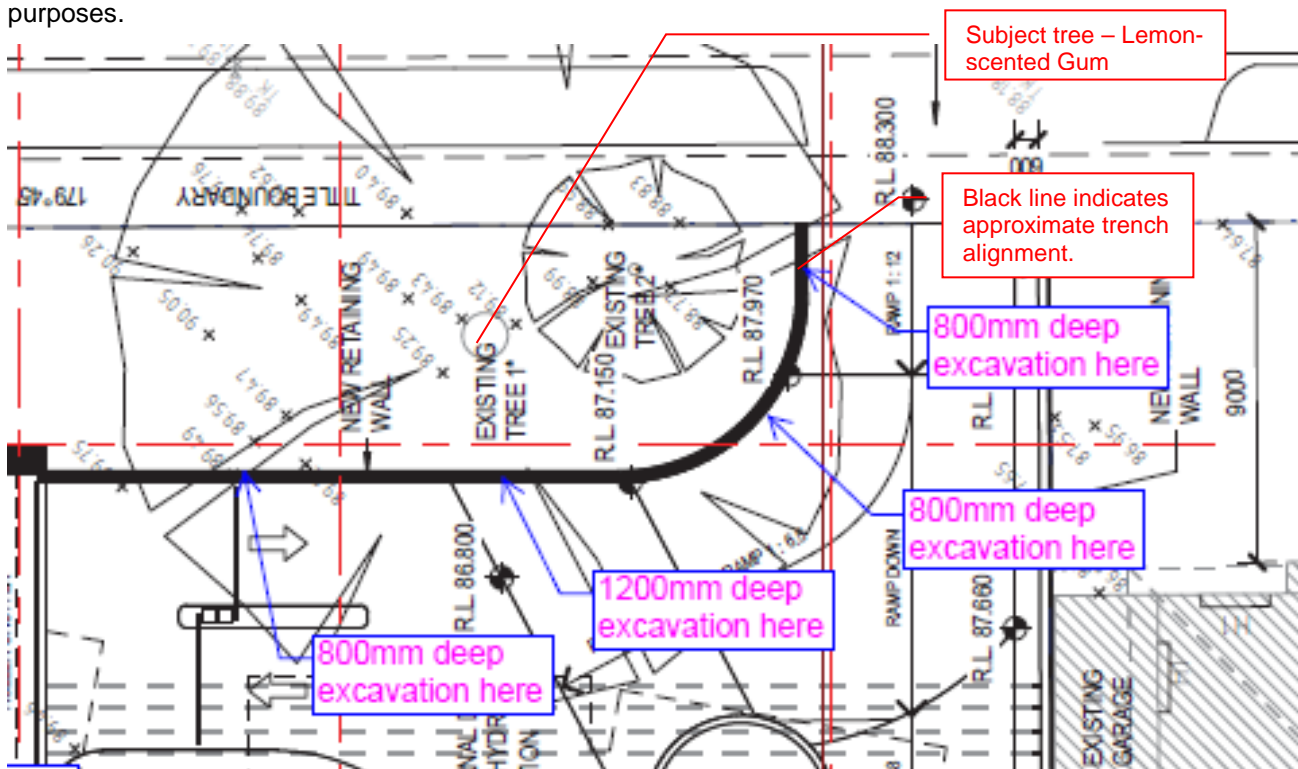
The investigation consisted of an L-shaped trench indicated by the solid black line in Figure 1. The trench extended from the edge of the existing driveway and 7.6 m to the south of the tree (a total of length of 8.5 m) and offset 3.5 m to the west. The depth of the trench was between 600 – 800 mm with a deeper exploration of 1.2m directly west of the trunk. An 800 mm deep excavation was undertaken between the driveway and northern property boundary. No excavation occurred within the existing driveway due to the concrete slab base.

**Figure 1:** Shows the location of the subject tree and the approximate alignment of the root investigation at 39 Regent Street, Mount Waverley

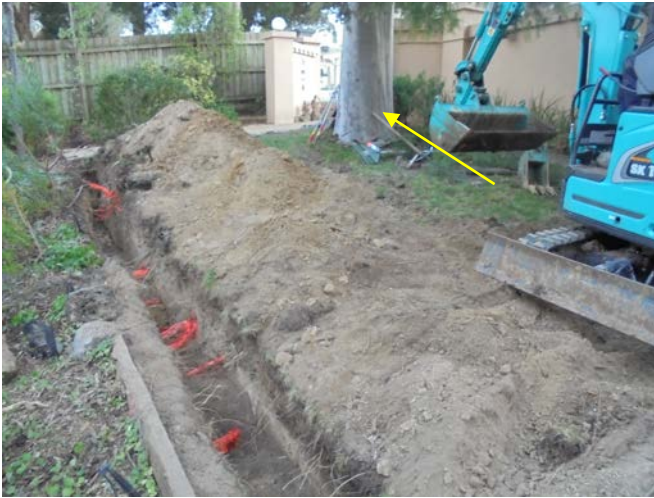
**Above left:** View to the north showing the western trench alignment in relation to the subject tree.

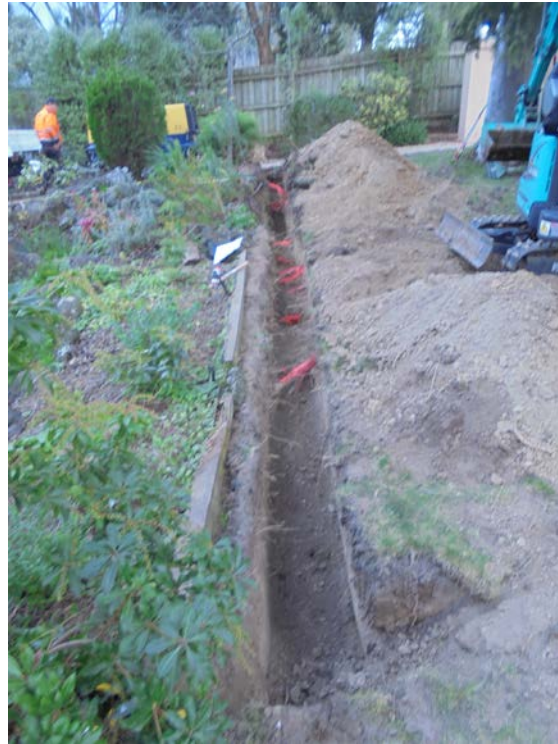
**Above right:** View to the north showing the western trench alignment. Exposed woody roots have been painted in pink for photographic purposes.

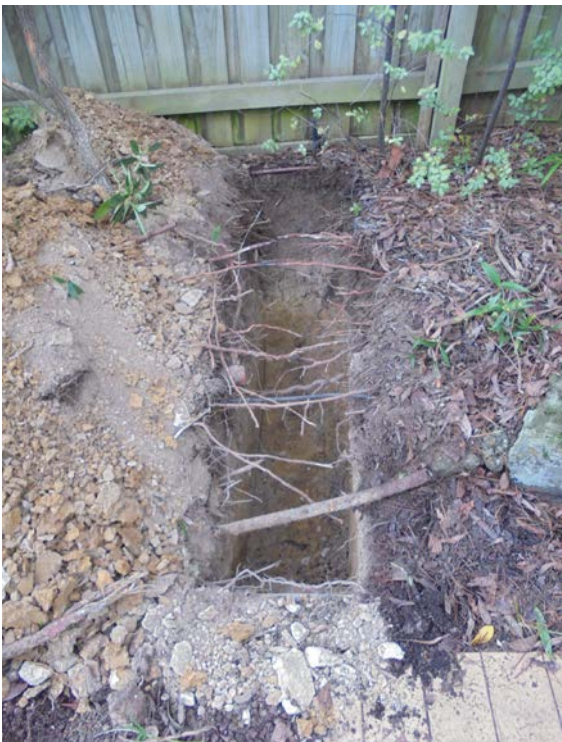
**Above Left:** Shows the excavation between the driveway and northern property boundary.

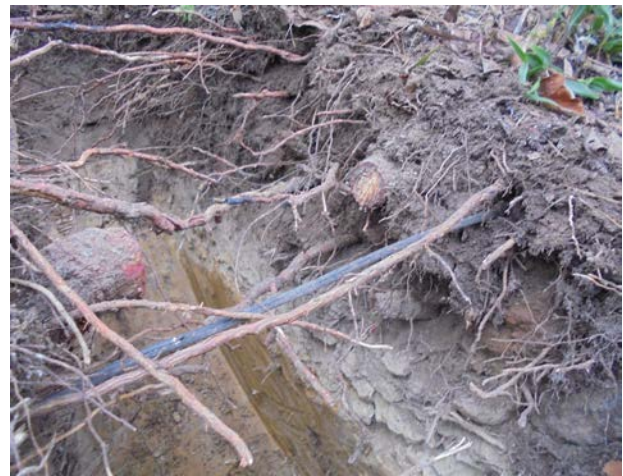
**Above Right:** Shows the exposed root mass from the adjacent Monterey Pine within the top 400mm soil profile.

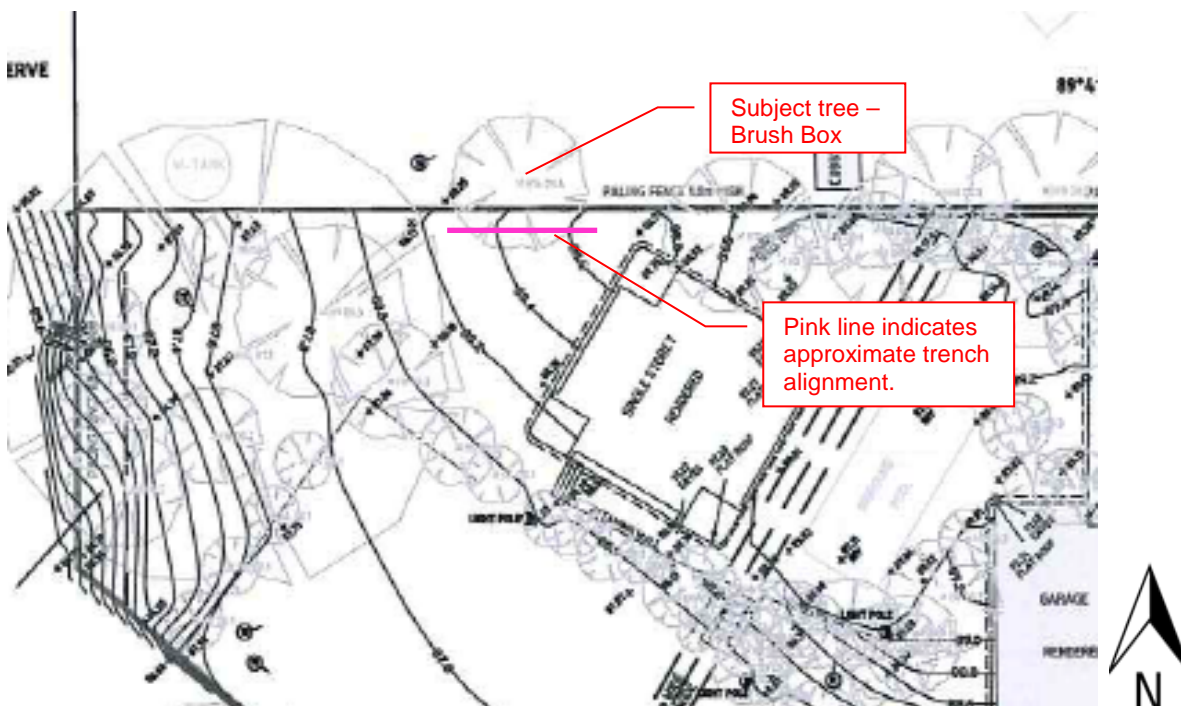
**Figure 1:** Shows the location of the subject tree and the approximate alignment of the root investigation at 35 – 37 Regent Street, Mount Waverley.

The investigation trench followed an east/west alignment offset approximately 500mm from the common property boundary. The trench was 250 - 300mm wide x 500mm deep x 4800mm in length.

Tree roots varying in diameter was observed throughout the trench alignment at different soil depths from 90mm to 500mm deep. The majority of roots were located at the western and eastern ends of the trench and within the top 200mm of the soil profile. Within the top 200mm soil profile, one root 80mm Ø (considered to be a higher order root), two roots, 40 mm and 50 mmØ and eight roots less than 30 mmØ were observed. Six (6) lower order roots (less than 30 mmØ) were observed below 200 mm of the soil profile.

The root investigation noted a moderate amount of roots developing into the subject site with the majority being lower order roots (less than 30 mmØ). The subject tree was semi-mature in age displaying fair health and expected to increase in size into the future. Vigorous, semi-mature trees are able to well adapt to root loss as they have readily available reserves to compartmentalise pruning cuts and develop new roots. Brush Box trees have a good tolerance to root loss and disturbance which is a reason why they are widely planted in the urban environment, particularly as street trees. Even though the tree is showing good vigour, some initial impact to tree health may occur with the loss of the exposed roots. However, the ongoing condition of the tree is expected to be maintained where the growing environment is protected during construction. New root development would also be expected to the east and west of the subject tree within the adjoining property as the area was open with no discernible barriers to continued root development. To minimise the impact upon tree health, the construction footprint should be no closer than 2.4m SRZ attributed to the tree.

- c) Within proposed designs, the existing site conditions between the common boundary and construction footprint, and for the diameter of the 4.2m TPZ must be maintained. No soil grade changes are to occur within this area.

- e) The remaining TPZ area must be protected during all phases of development in accordance with AS4970. This may include; installing suitable ground protection engineered for the anticipated load so as to avoid compaction of the underlying soil and allow for continued water percolation and gaseous exchange. A ground protection system in the form of rumble boards strapped or tree protection matting laid over mulch or aggregate with geo-textile fabric over the soil surface would be appropriate to protect the growing environment.

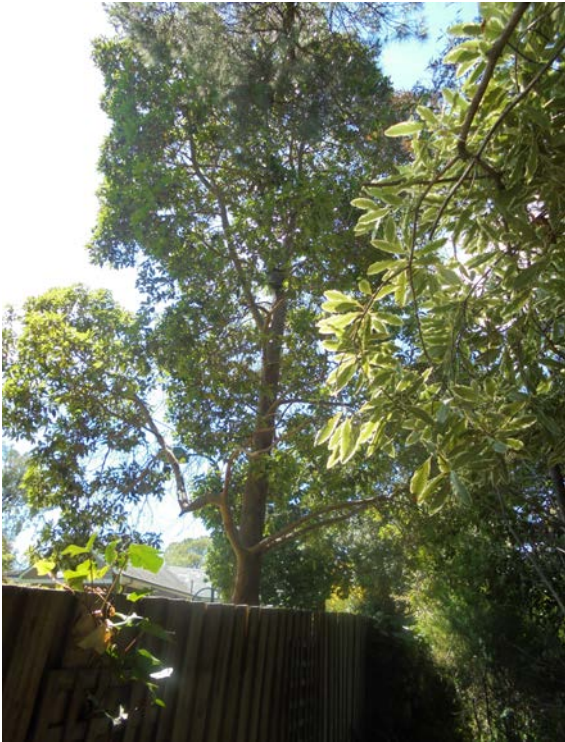
**Above left:** Showing the relative size, condition and location of the subject tree, a semi –mature Brush Box (*Lophostemon confertus*) in fair condition.

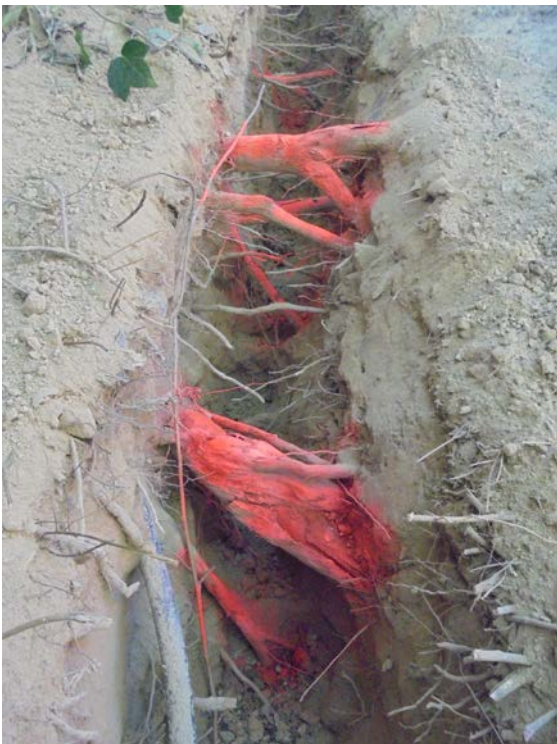
**Above Left:** Shows the root mass at the western end of the trench.

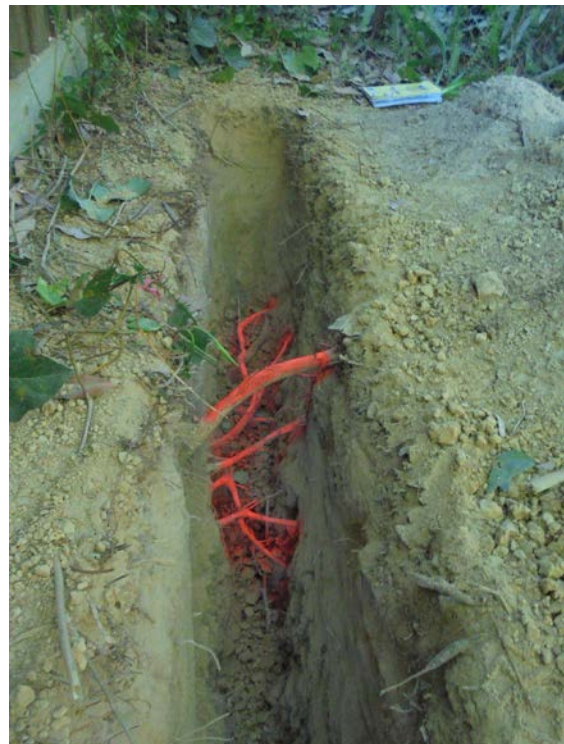
**Above Right:** Shows the root mass to the eastern end of the trench.

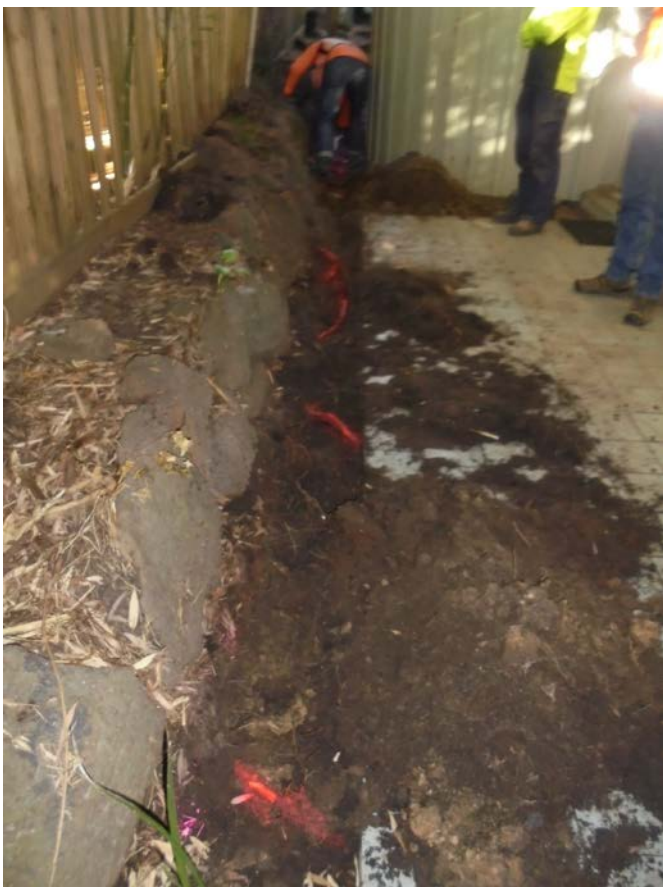
**Figure 1:** Shows the trench alignment adjacent to the group of conifers located in the adjoining northern property at 35 – 37 Regent Street, Mount Waverley. Exposed roots are highlighted in pink.

The trench investigation was undertaken between a narrow gap between the base of the existing rock retaining wall and paved section extending out from the existing residence. Further investigation continued in an easterly direction past the water tank and hot water service. The trench was 200mm wide x 200mm deep x 8000mm in length.

A 25mm PVC conduit used for irrigation was noted along the length of the trench.

- a) Roots greater than 20 mmØ that are to be severed must be pruned with a final cut to undamaged wood. Pruning cuts should be made with sharp tools such as secateurs, pruners, handsaws or chainsaws. Pruning wounds should not be treated with dressings or paints. It is not acceptable for roots within the trees protection zone (TPZ) to be 'pruned' with machinery such as backhoes or excavators.
- b) Where roots within the TPZ are exposed by excavation, temporary root protection should be installed to prevent them drying out. This may include jute mesh or hessian sheeting as multiple layers over exposed roots and excavated soil profile, extending to the full depth of the root zone. Root protection sheeting should be pegged in place and kept moist during the period that the root zone is exposed.

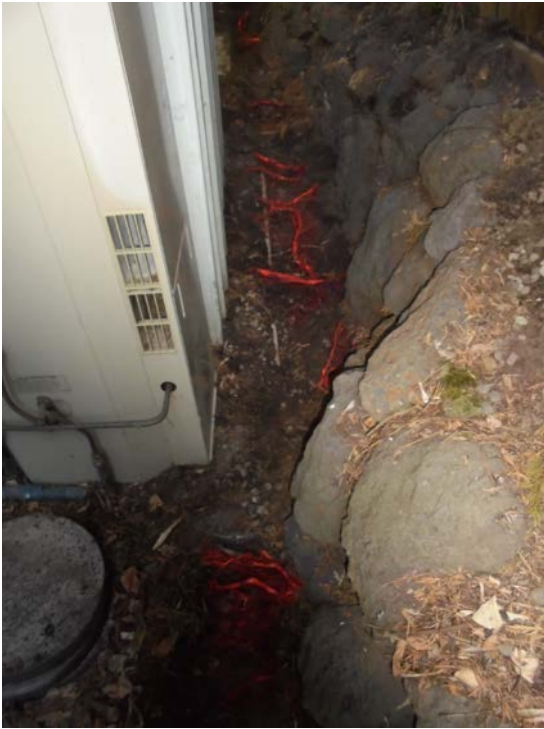
**Above left:** Shows the eastern end of the trench adjacent to the hot water service.

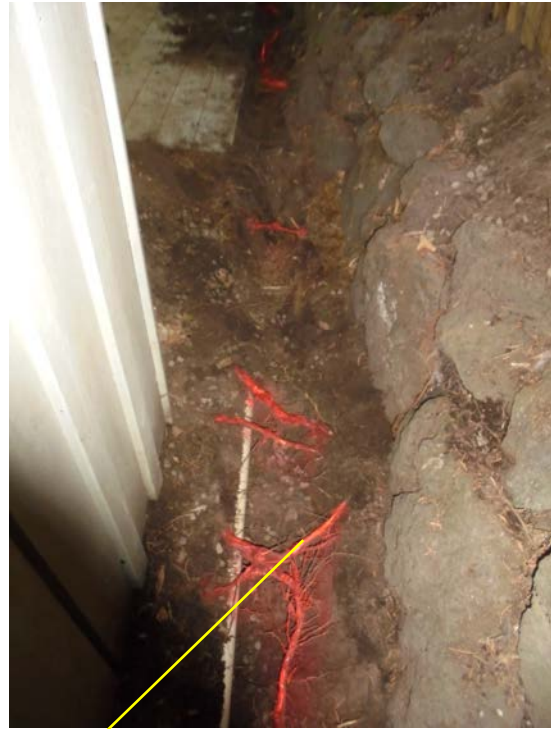
**Above right:** Shows the exposed roots adjacent to the wooden structure surrounding the water tank. The white line shows the PVC irrigation pipeline.

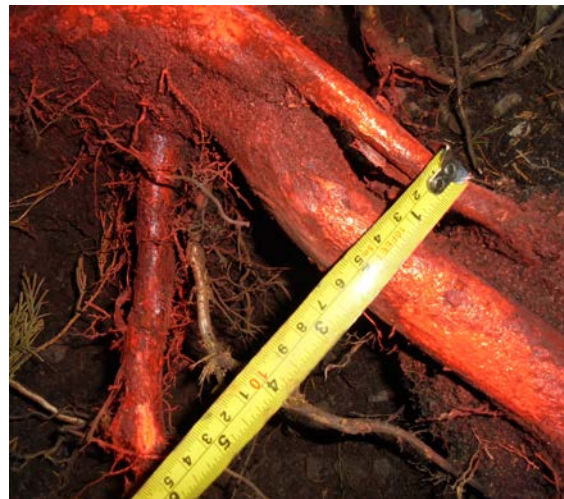
**Above Right:** Shows a branching root of 30 mmØ with two roots of 10mmØ extending from a root of 60 mmØ.
