Street Tree Renewal Information

Leicester Avenue, Glen Waverley

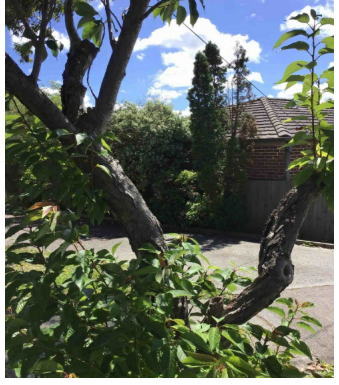
Ref No.	Street Address	Assessment Outcome	Follow Up Action	Current Tree Species	Tree Condition Assessment (*ULE <2 Years)	Tree Image
68	87 Leicester Avenue	Tree to be removed	Replacement tree to be planted	<i>Prunus serrulata</i>	Significant decay.

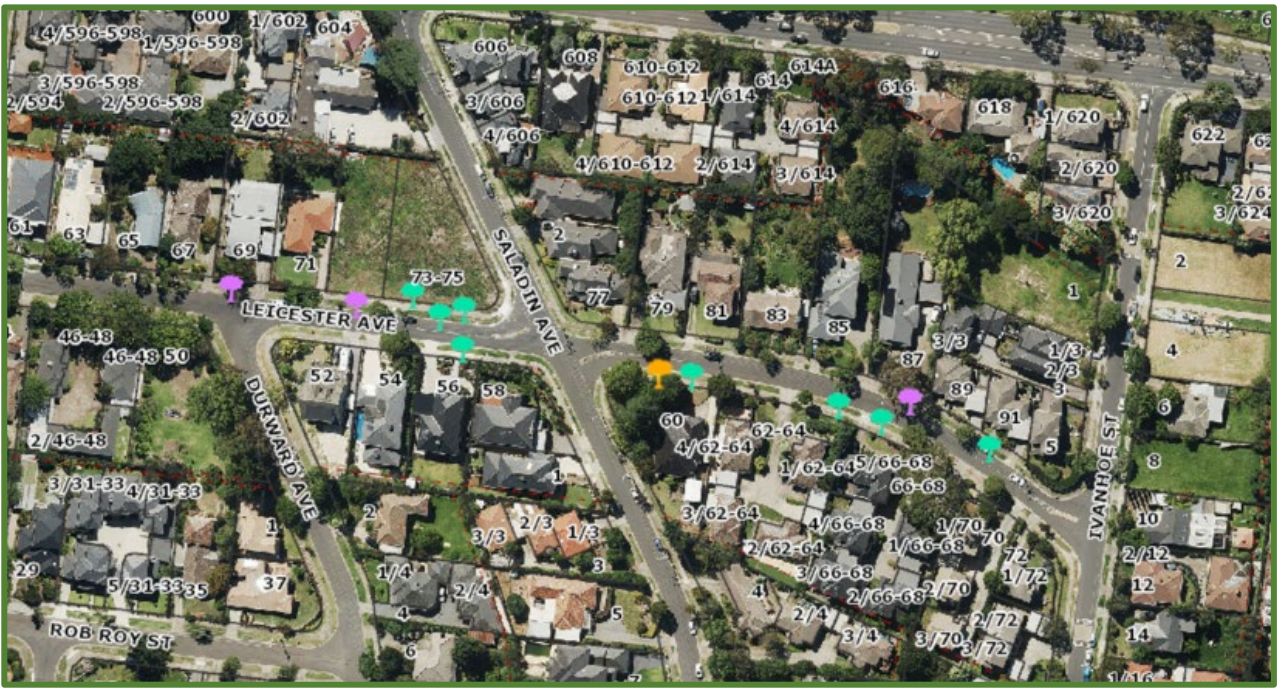
Street Overview

The map below details the removals, replacements and infill plantings. All other trees have been assessed as having more than two years' useful life and will be retained.
